Subject: Structural Condition Assessment
105 E Main Street
Vergas, MN
Project Number: 20.066

The purpose of this letter is to report the findings of a structural condition assessment of the building located at 105 E Main Street in Vergas, MN as directed by Julie Lammers.

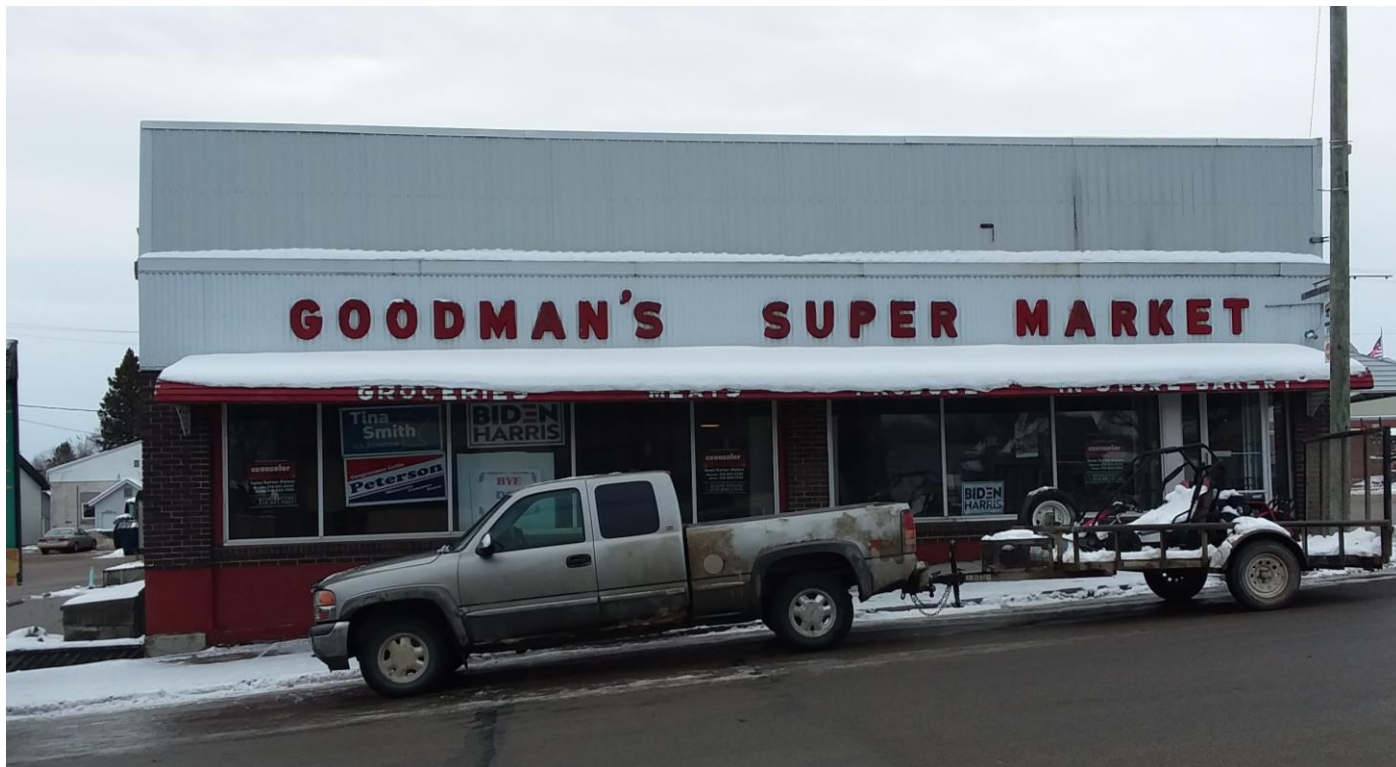
Photo #1 – North exterior wall

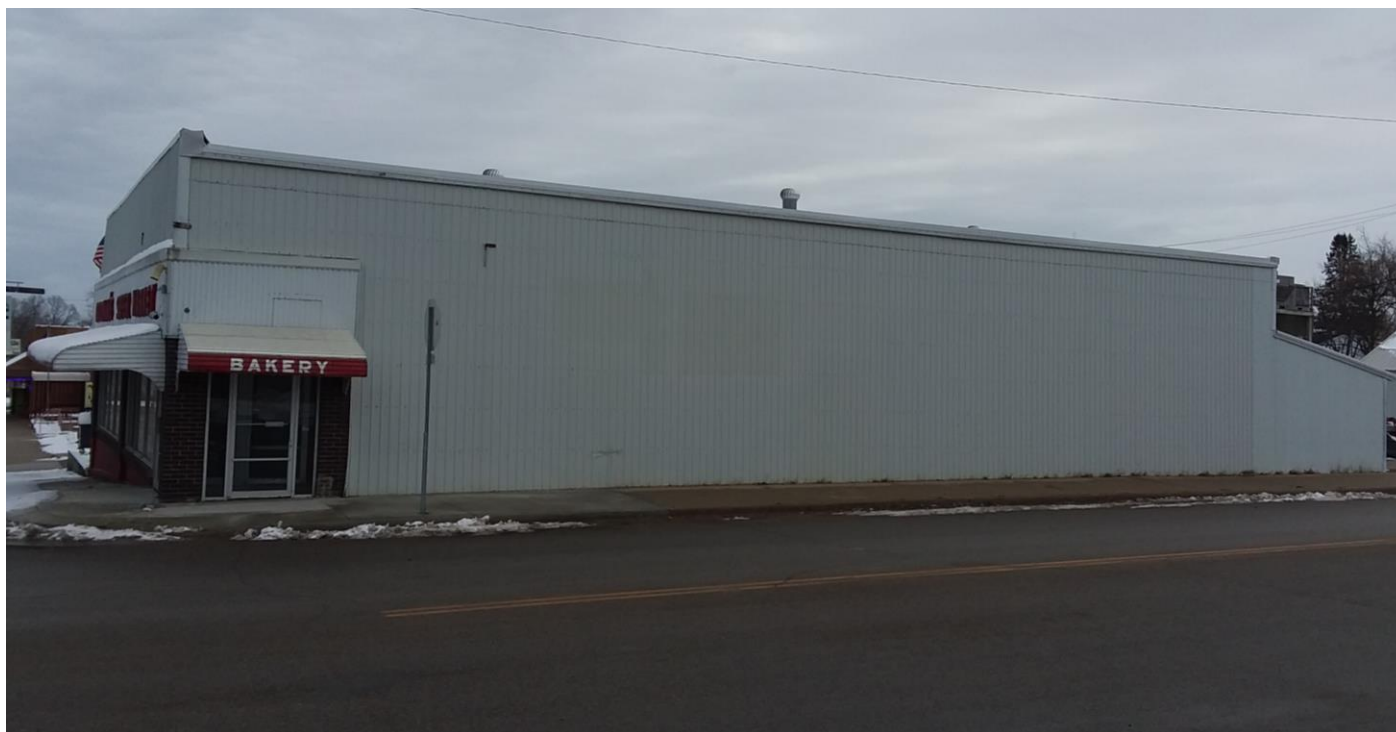
- a. The exterior walls of the existing building were constructed with wood studs.
- b. The west wall of the original building was out of plumb by approximately 3".
- c. The east wall of the original building varied from level to out of plumb by approximately $\frac{1}{2}$ ".
- d. The north and south walls appeared to be relatively plumb.

- e. The west wall has experienced significant movement. The rot and crushing of the wood plate below the floor joists on the west side of the building likely contributed to the condition.

Photo #2 - West exterior wall

- Reconstruction or replumb the west exterior wall.
- Possible reinforcement and reconstruction of the roof system.
- Additional repairs and reinforcements may be discovered after the removal of existing finishes.

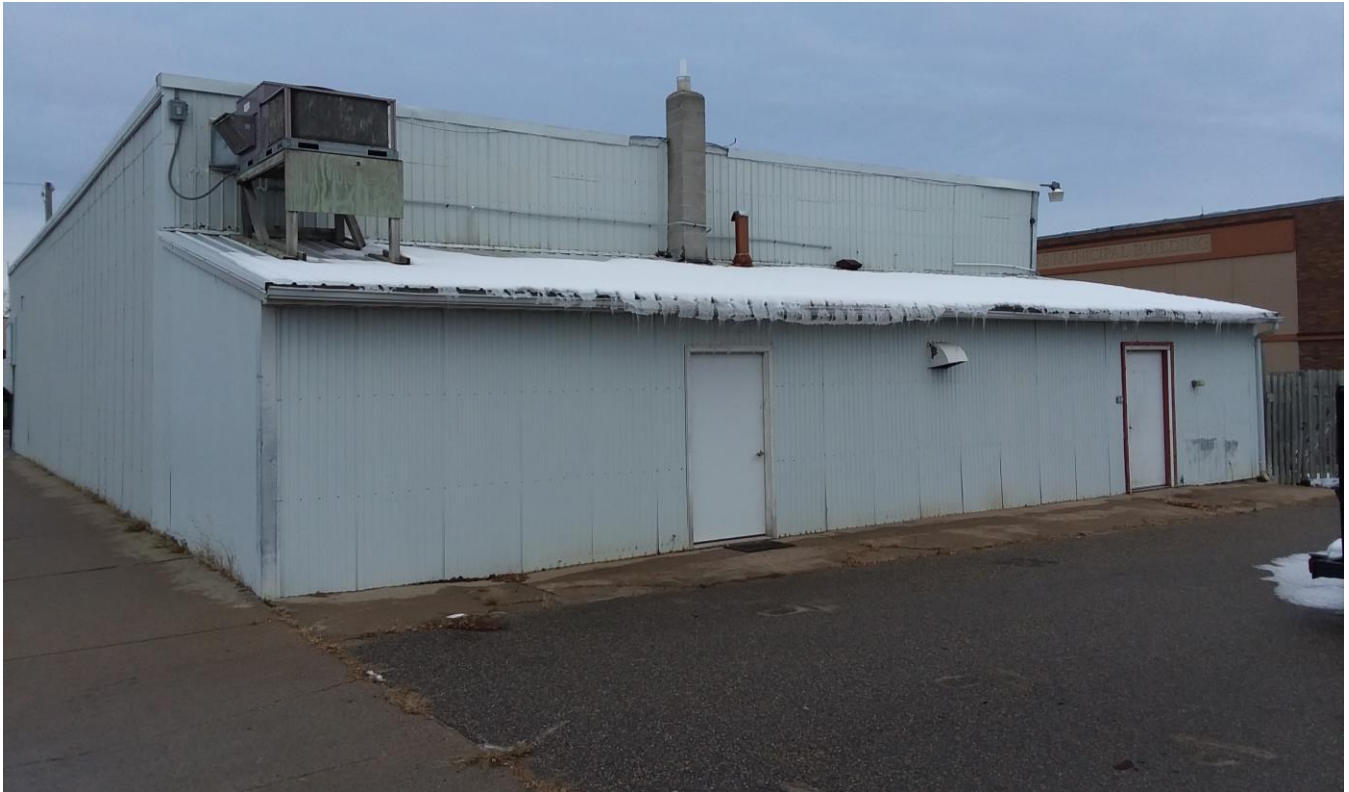
Photo #3 – South exterior wall

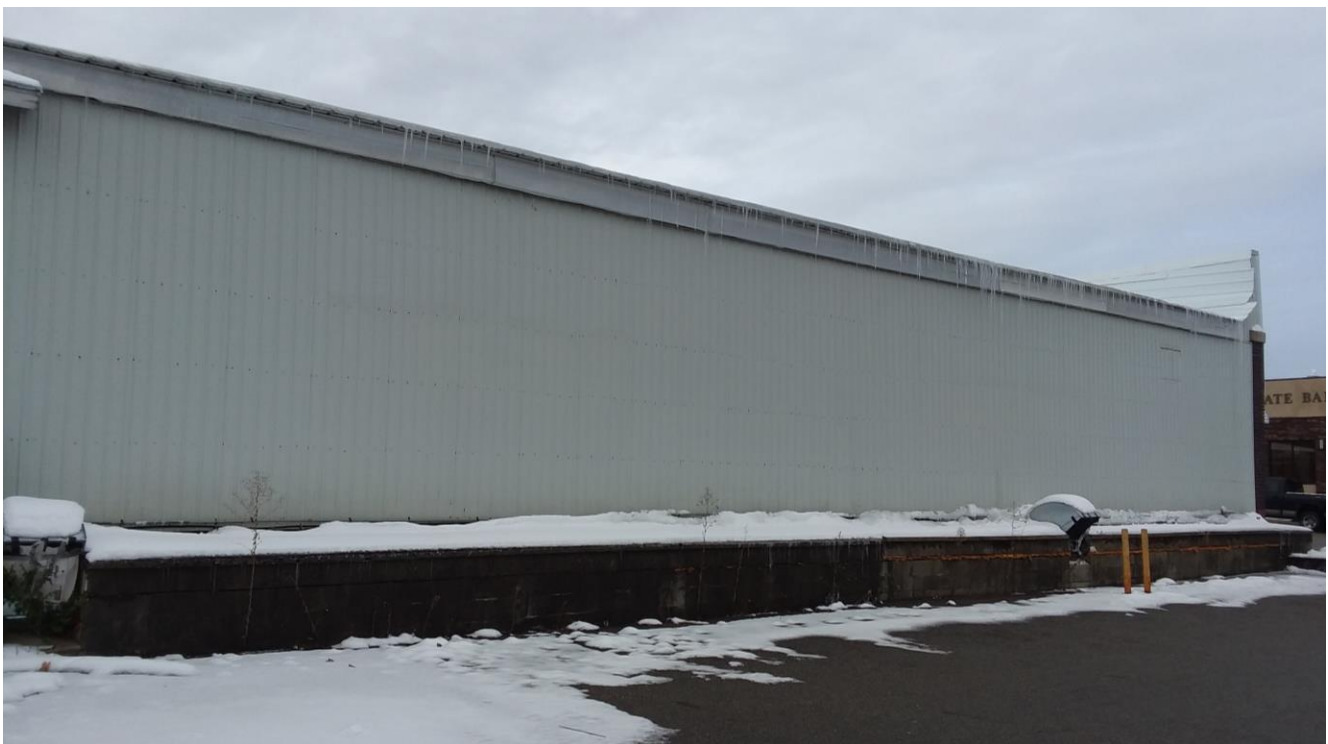
Photo #4 – East exterior wall

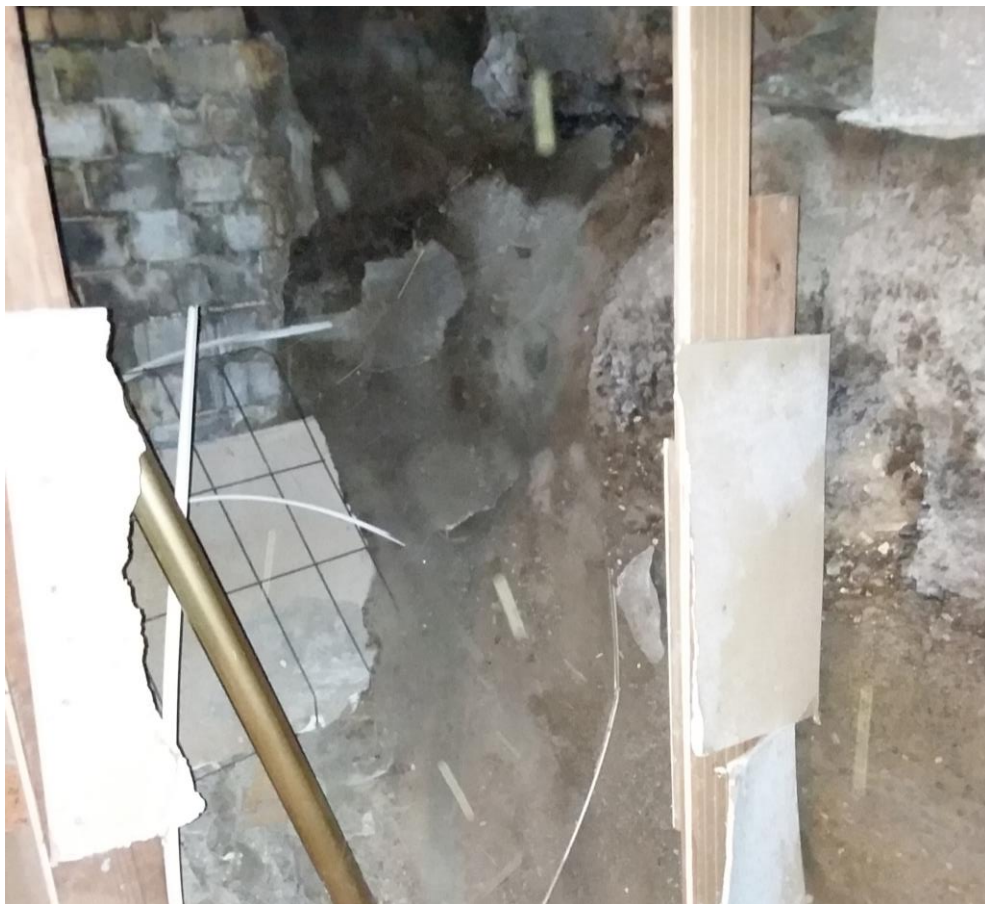
- c. The northwest corner of the foundation had failed and soil had infiltrated into the basement. See photo #5.
- d. There was a horizontal crack in the foundation wall on the north end of the east foundation wall near an existing opening that had been filled with concrete. See photo #6.

- a. The foundation walls have experienced distress or failure at multiple locations.
- b. The slab on the east side of the building appears to be directing water towards the building.

Photo #5 – Foundation wall failure at northwest corner

- Repair and/or reconstruction of the existing foundation wall.
- Modification to the foundation wall for a new connection between the foundation wall and floor joists. Due to the foundation construction and condition of the foundation walls reconstruction of the foundation walls may be required.

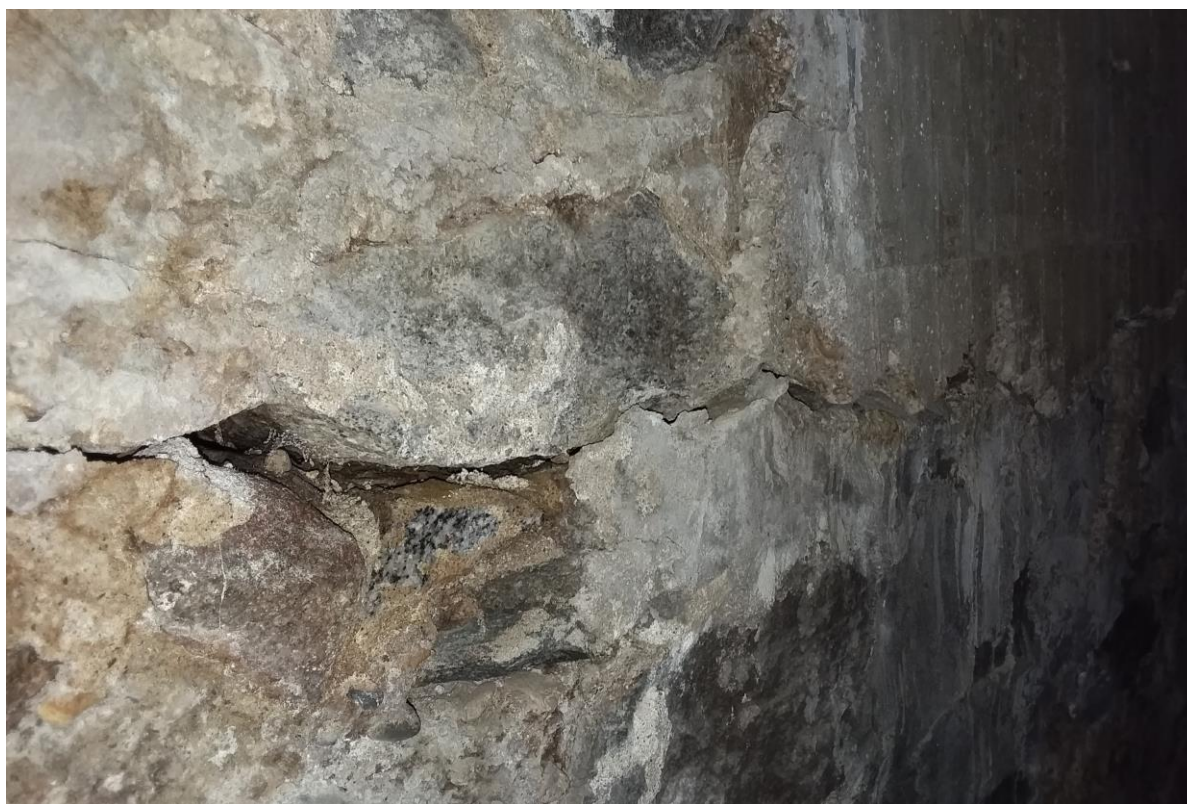
Photo #6 – Horizontal crack at north end of east wall

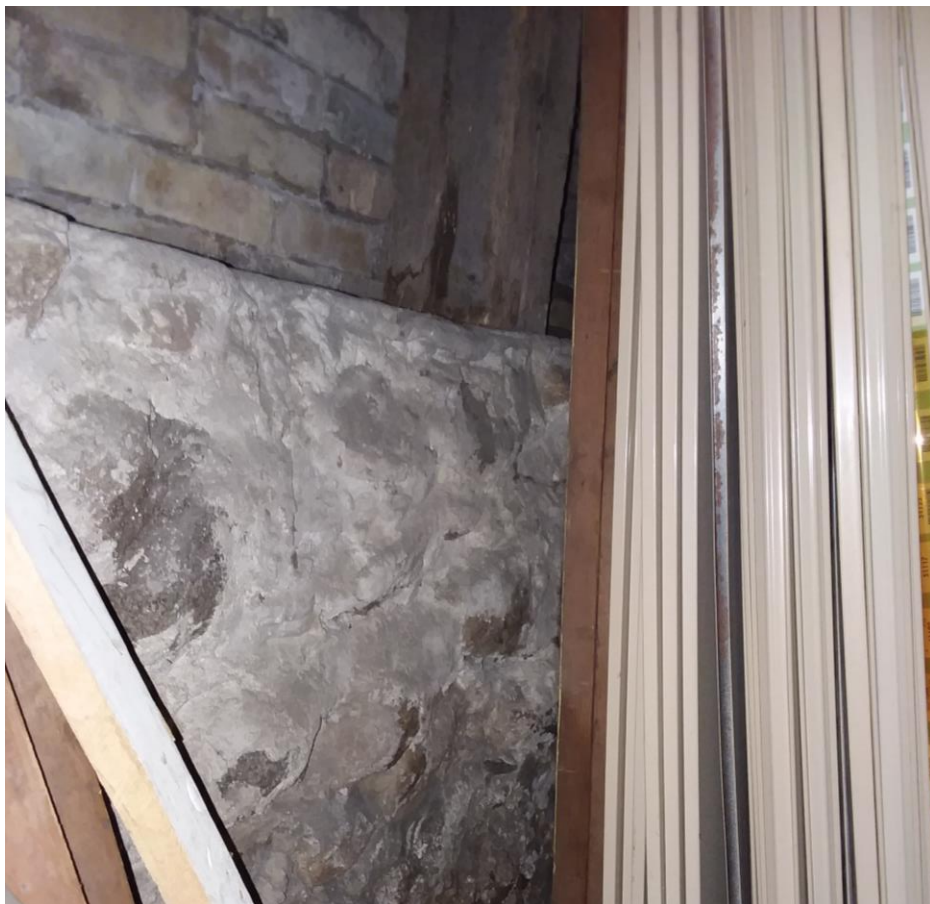
- e. The north side of the west foundation wall had a stepped gravity retaining wall system which consisted of a 3'-0" tall boulder foundation wall and a 4'-4" tall brick wall. See photo #7. The retaining wall was offset to the inside of the exterior wood frame wall. The footing or foundation wall construction below the exterior wood frame wall was unable to be verified.

Photo #7 – North end of west foundation wall

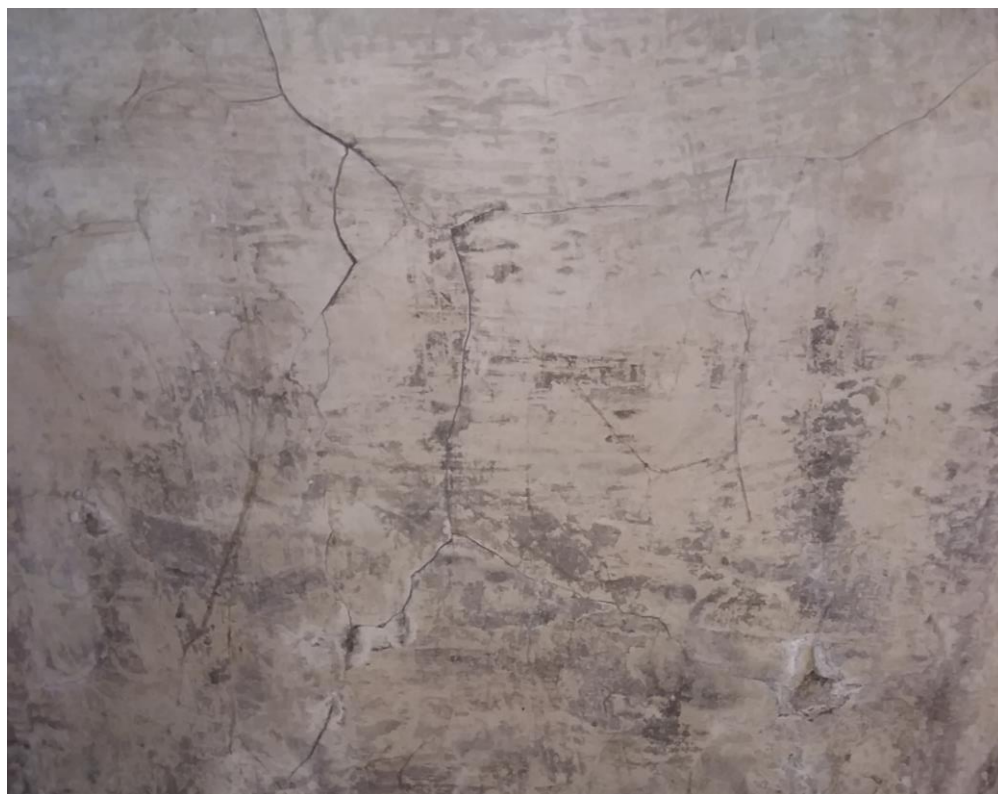
- f. The center of the west foundation had a crawl spaced foundation system that extended into the basement.
- g. The south end of the west wall appeared to have a shotcrete or cementitious coating. The west end of the south wall was cracked and showing signs of distress. See photo #8. The south wall of the crawl space had experienced failure and soil from the crawl space had infiltrated into the basement. See photo #9.

Photo #8 – Foundation wall distress at west end of south wall

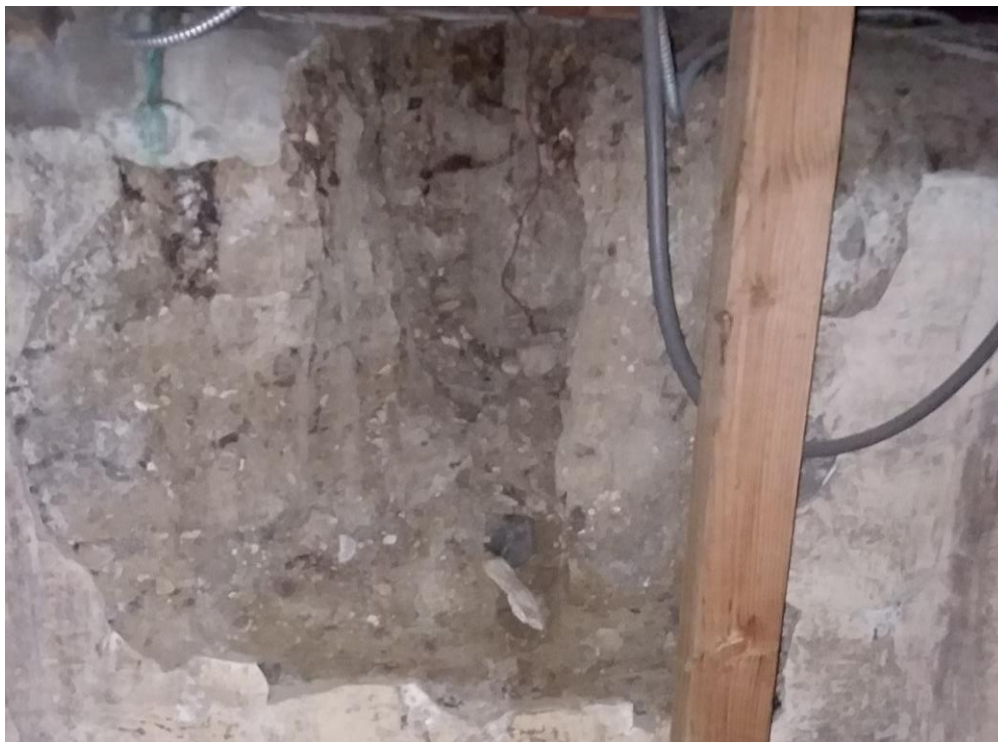
Photo #9 – Foundation failure on south end of crawl space

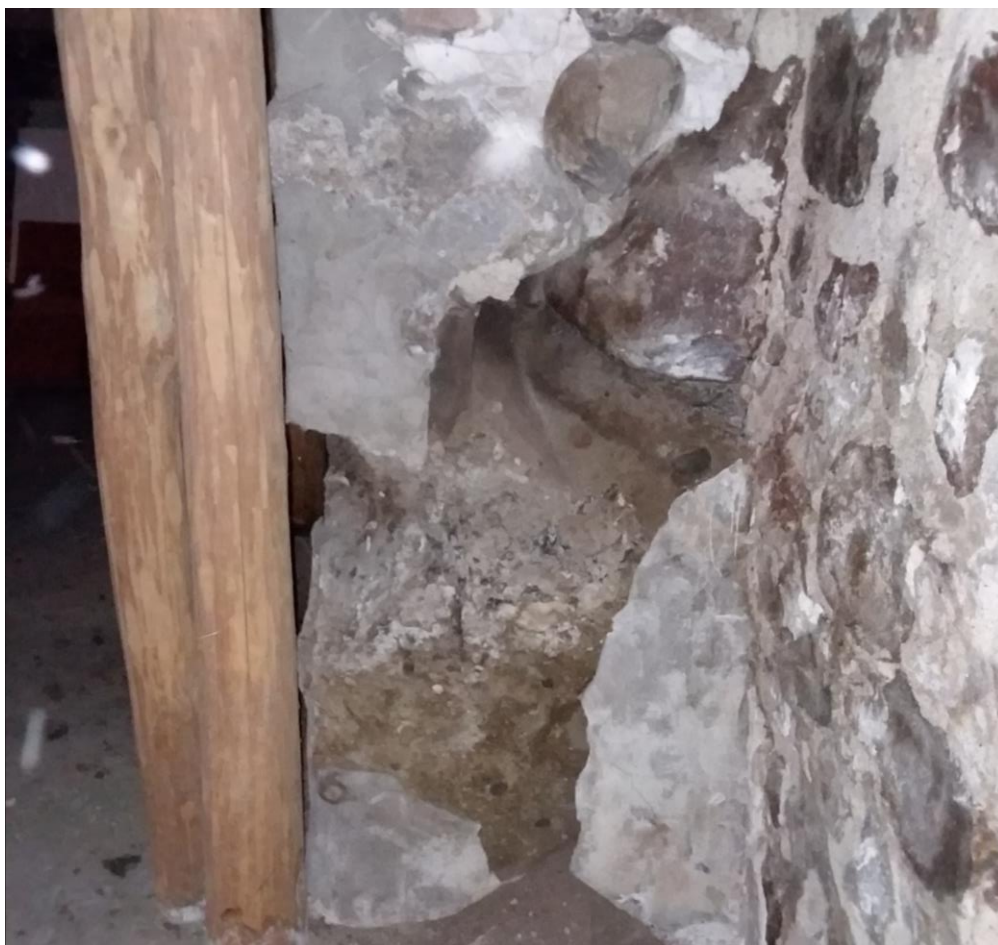
- h. There was an interior boulder foundation wall on the south side of the basement that was approximately 2'-0" wide.
- i. There was a pier on the north foundation wall which supported the center roof beam. The pier experienced significant deterioration and was missing a boulder. See photo #10.

Photo #10 – Pier deterioration on north wall

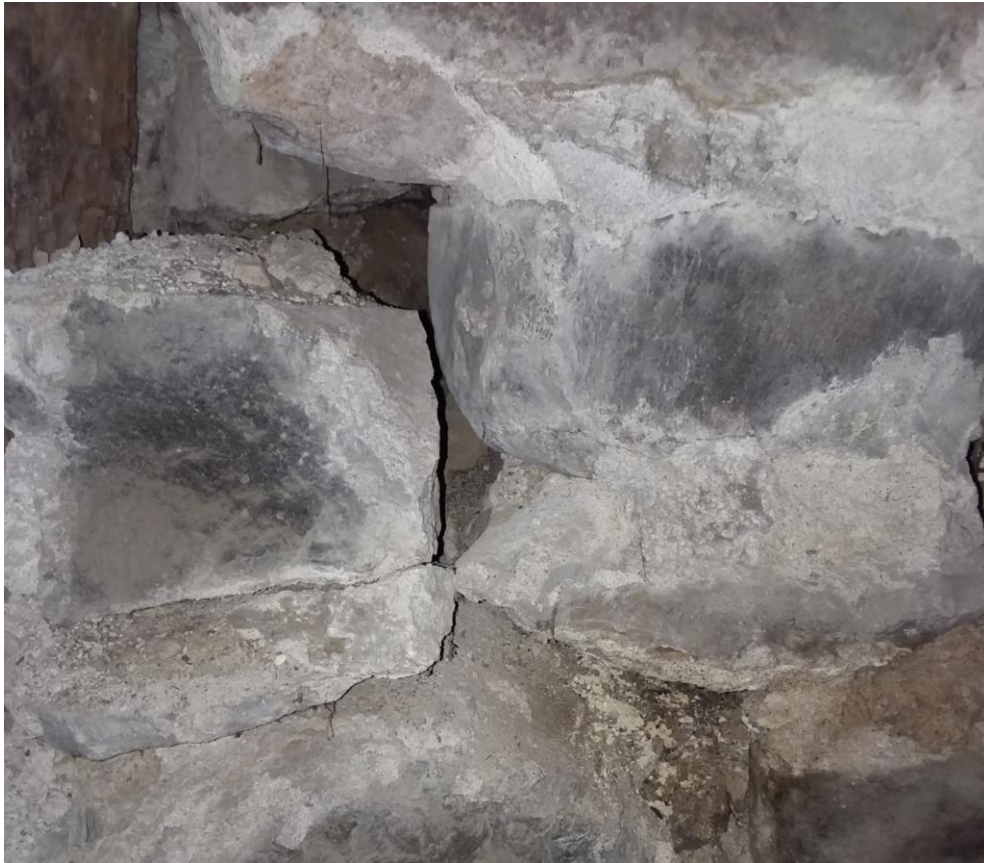
- j. There were large voids in the stone foundation wall on the east side of the south foundation wall. See photo #11.
- k. There was a masonry wall on the east side of the building that supported a concrete slab. The wall was showing signs of distress. See photo #12. The slab was approximately 3'-0" wide and was snow covered at the time of the site observation. The snow on top of the slab was removed at the distressed masonry wall to better observe the slab. The slab sloped toward the building at the location that the slab was observed. The roof sloped from west to east resulting in the slab collecting the entire roof drainage.

Photo #11 – Large voids in south foundation wall

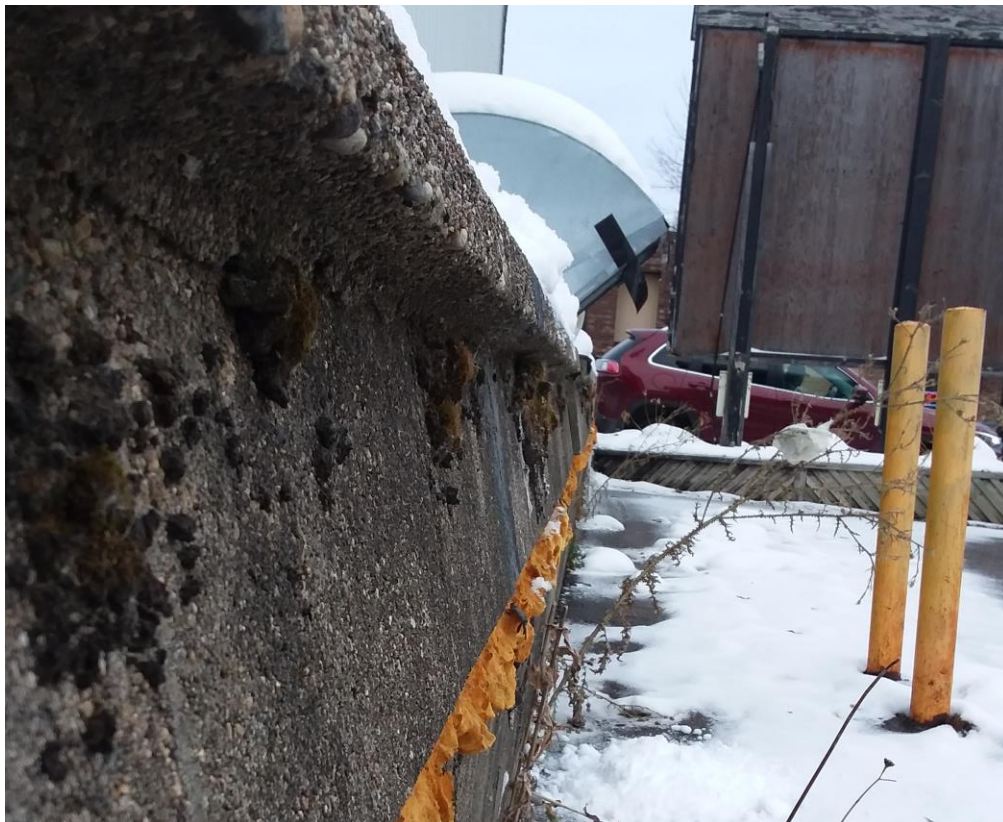
Photo #12 – Distressed masonry wall on east side of building

- Temporary shoring of the foundation walls during floor system construction.
- Reconstruction of the exterior slab and masonry wall on the east side of the building.

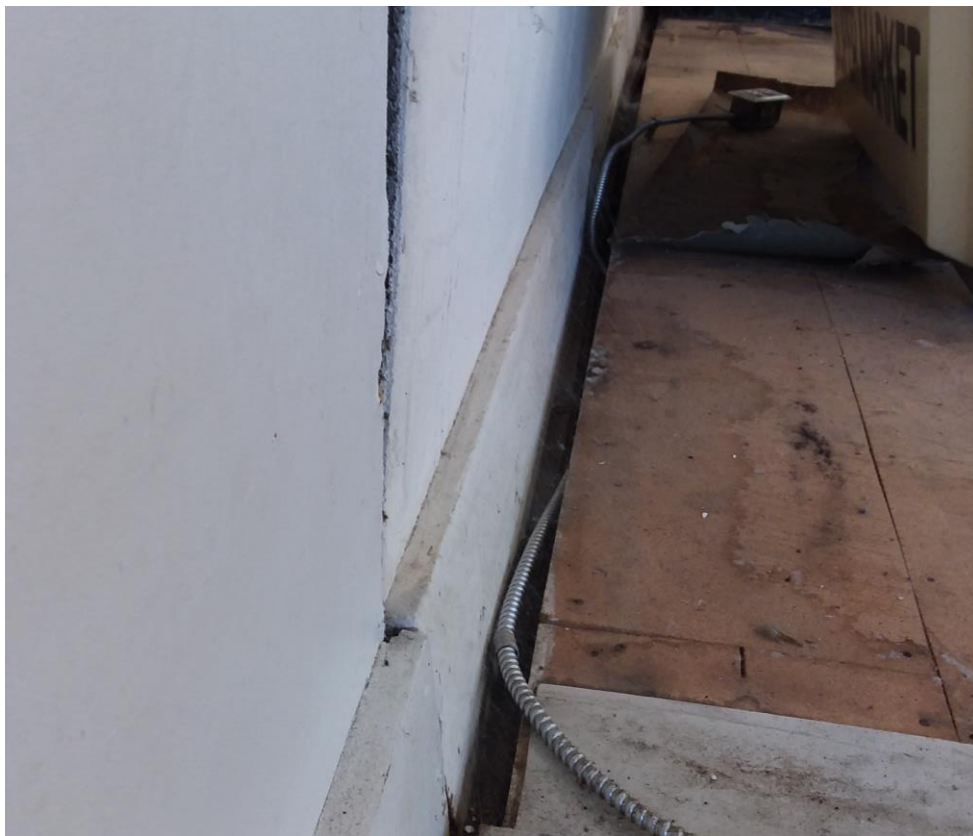
- a. The floor system of the original building was constructed with rough cut 2x8 joists at 16" on center.
- b. There was a 2" gap between the base of the wall and the sub floor at the north end of the east wall. See photo #13.

Photo #13 – Gap between east wall and floor sheathing

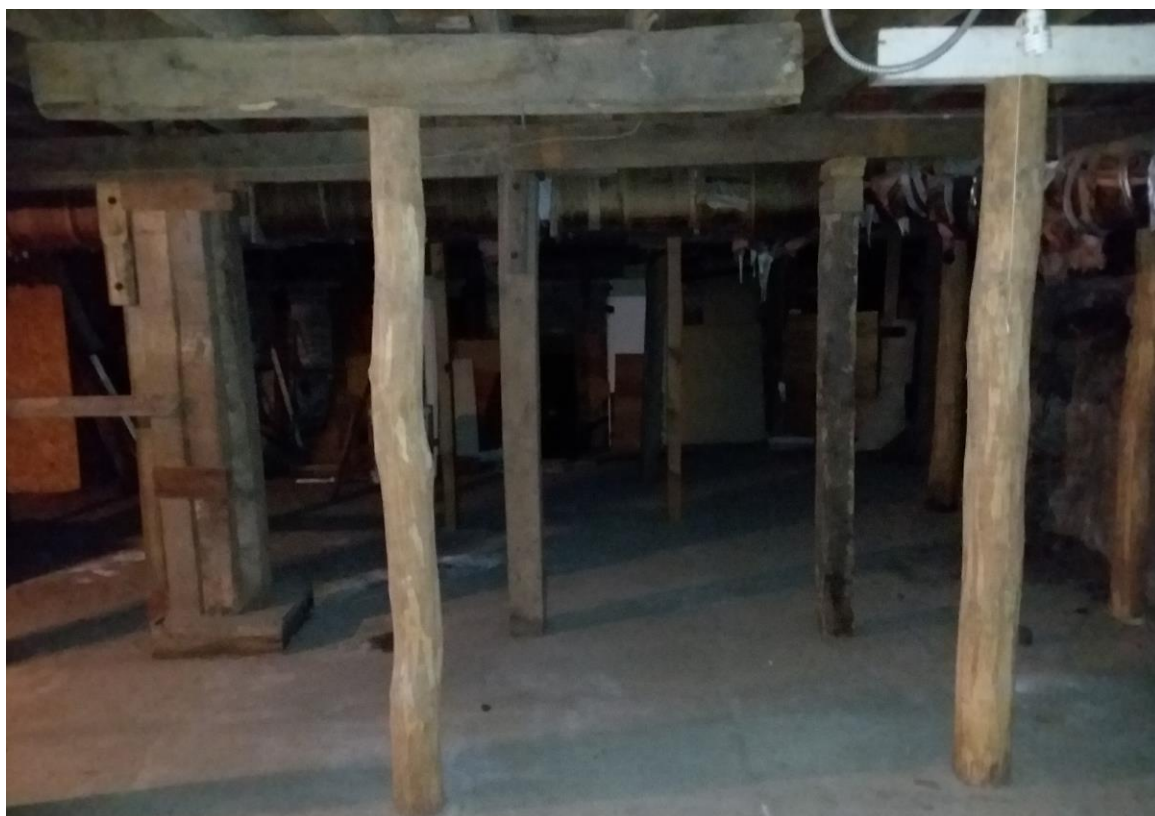
- c. The floor system was out of level throughout the entire floor system by up to 2". There were several rows of beams and columns that appeared to have been added in attempt to re-level the floor. The wood beams varied between sawn lumber and rough-cut lumber. Several of the columns were centered below the beams creating a cantilevered beam condition. The columns varied between sawn lumber, rough sawn lumber, and log columns. See photo #14. There were no visible signs of footings being added below the added columns.

- d. The columns that were added in the basement are not adequately treated and appear to bear on the existing slab. These columns should bear on adequately sized spread footings.

Photo #14 – Additional beams and columns supporting floor system

- Reconstruction of the wood beams and columns that have been added in the basement.
- Add new footings under new columns and beams in the basement.
- Reconstruction and/or repair of the floor system.

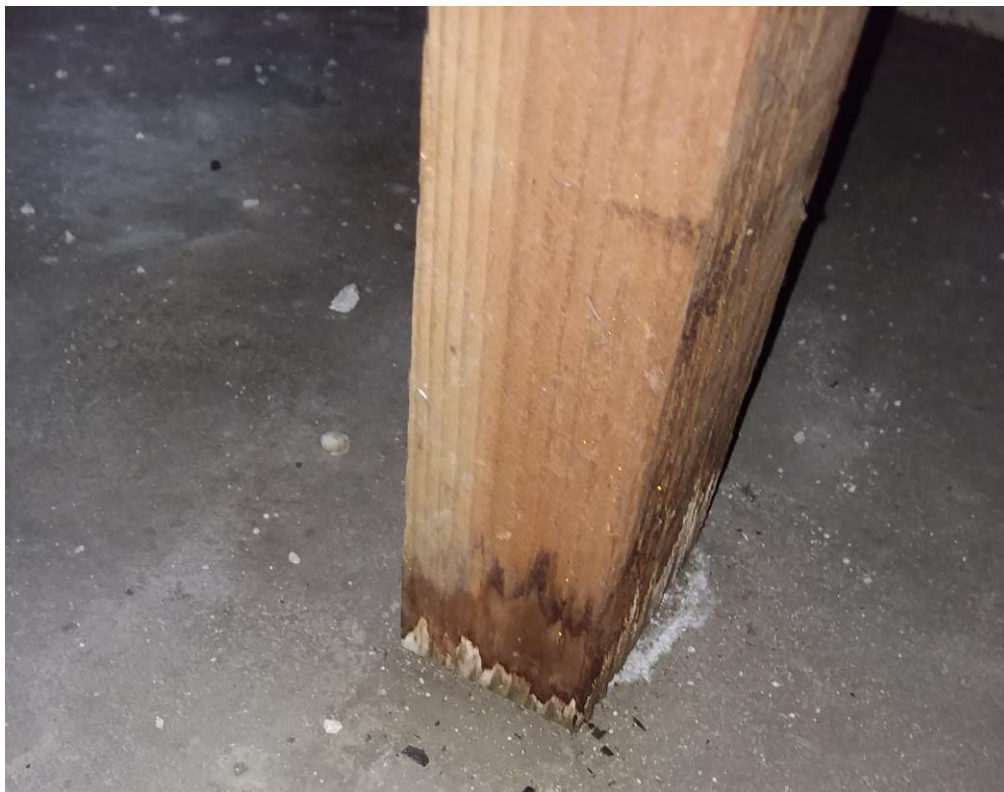
- d. Several of the untreated wood columns were absorbing moisture from the concrete slab. See photo #15.
- e. The floor on the west side of the original building sloped down approximately 2" towards the exterior wall over a length of 8'-0".

- c. The joists and sill plates in contact with concrete and soil were not treated. The joists and sill plates at multiple locations have experienced severe rot and deterioration. Current building codes require all wood in contact with soil or concrete to be treated. Untreated members exposed to moisture or in contact with concrete are likely to experience continued rot and decay and lead to additional building movement.

Photo #15 – Moisture at bottom of column

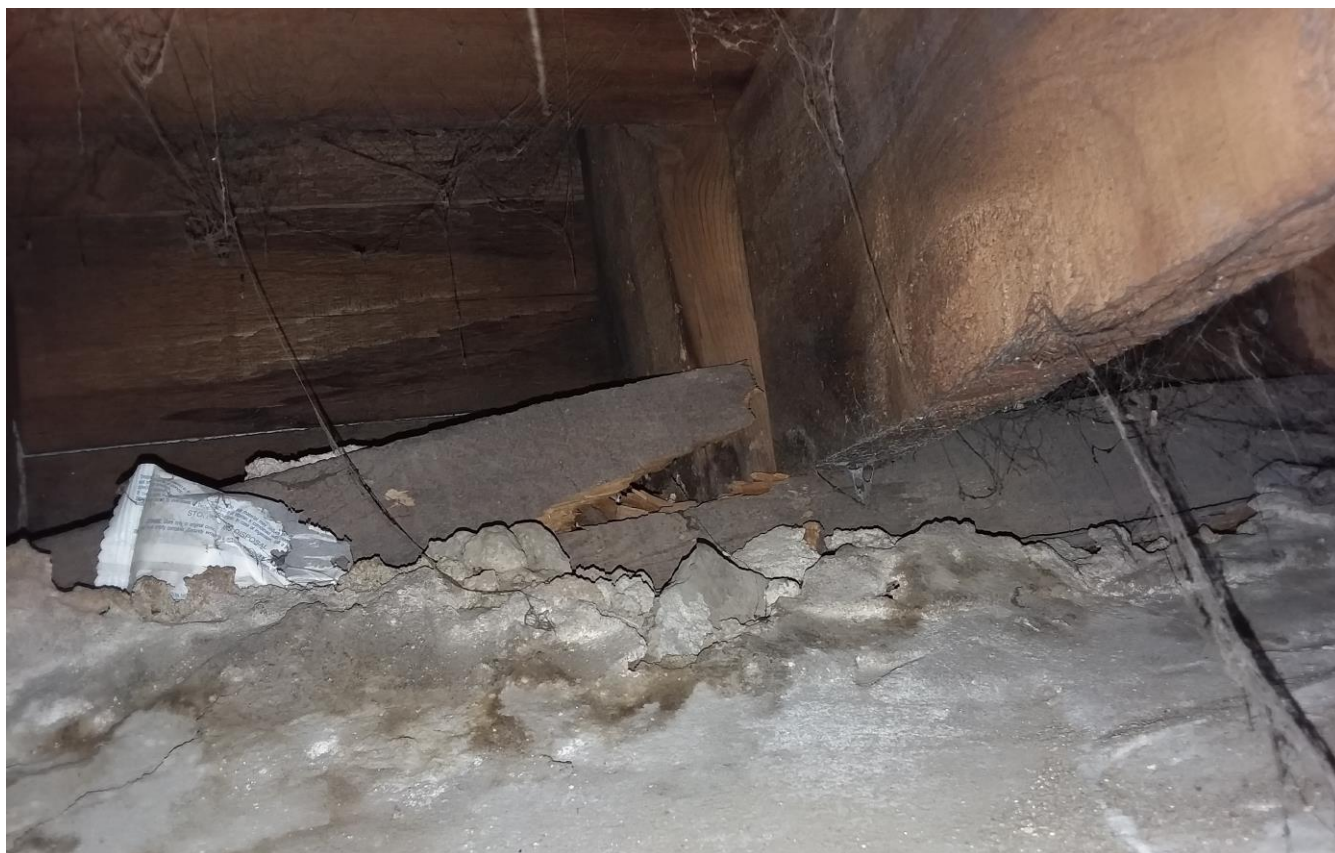
- f. The wood plate below the floor joists on the west side of the building experienced significant rot and was crushed and split below the floor joists. See photo #16.

Photo #16 – Rotted plate below floor joists on west wall

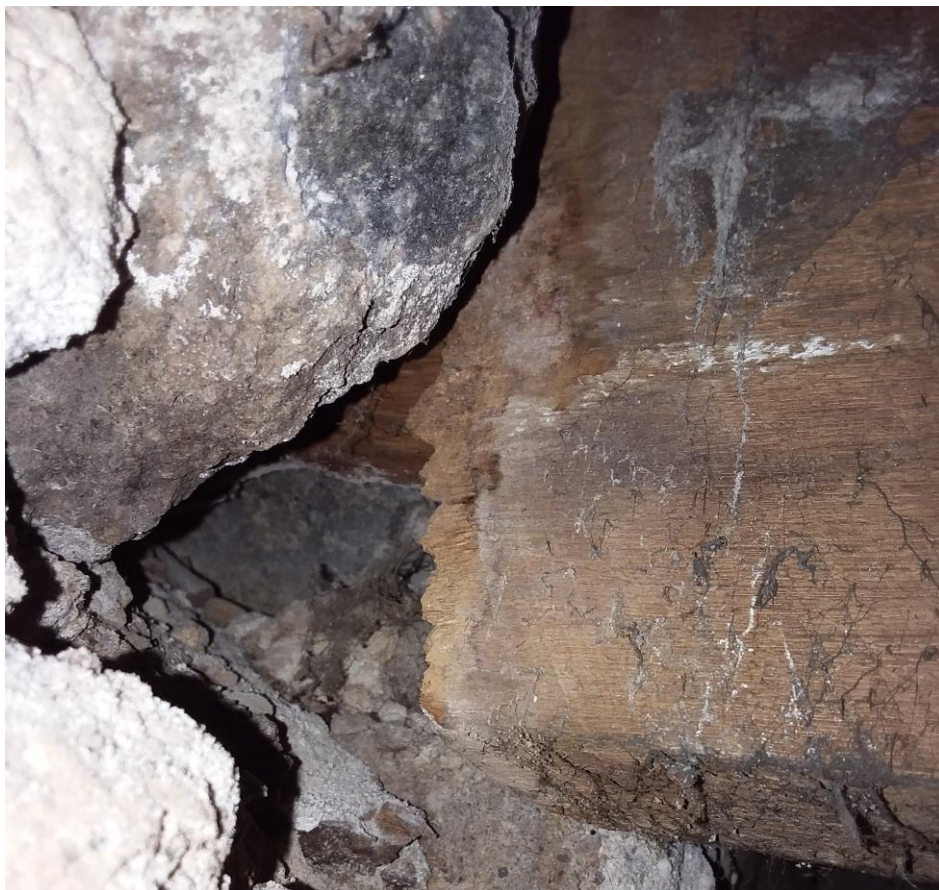
- g. The floor on the east side of the original building sloped up approximately $\frac{1}{2}$ " towards the exterior wall over a length of 8'-0".
- h. The floor joist on east side of the building were pocketed into the foundation walls. The floor joist experienced various degrees of rot at the bottom of the joist where the joist contacted the foundation wall. The rot at several joists extend over an inch into the joist. See photo #17.
- i. Beams and columns were installed below the significantly rotted joists to support the floor system at the foundation wall. See photo #18.

Photo #17 – Joist deterioration at east wall

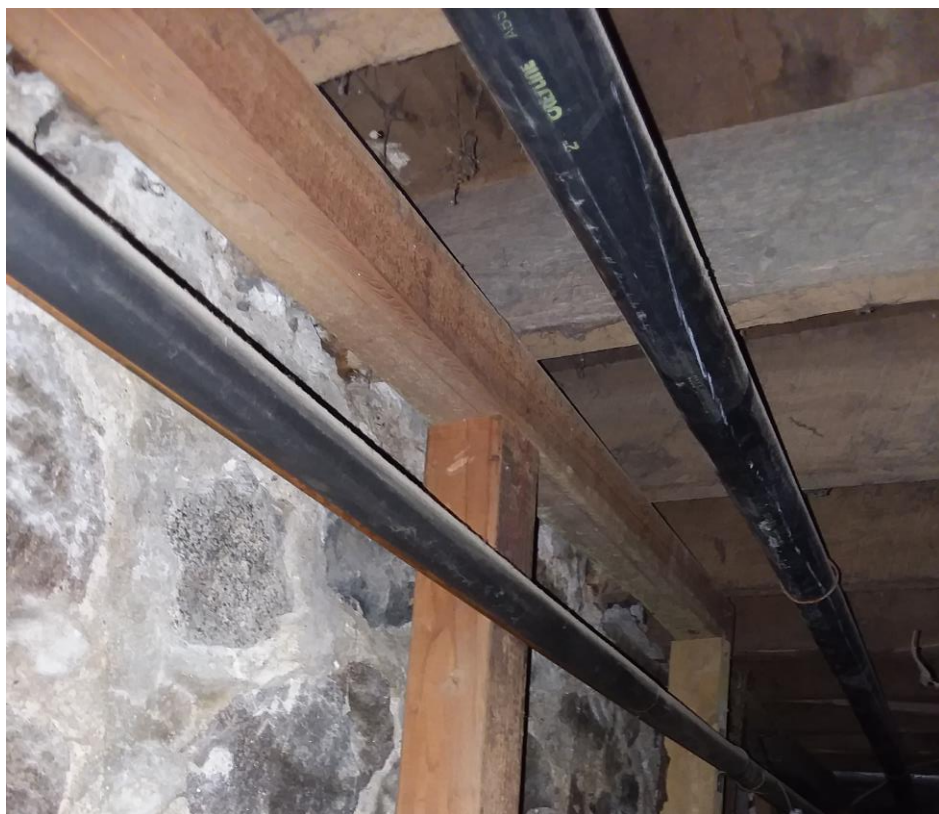
Photo #18 – Beam and column below joists at east wall

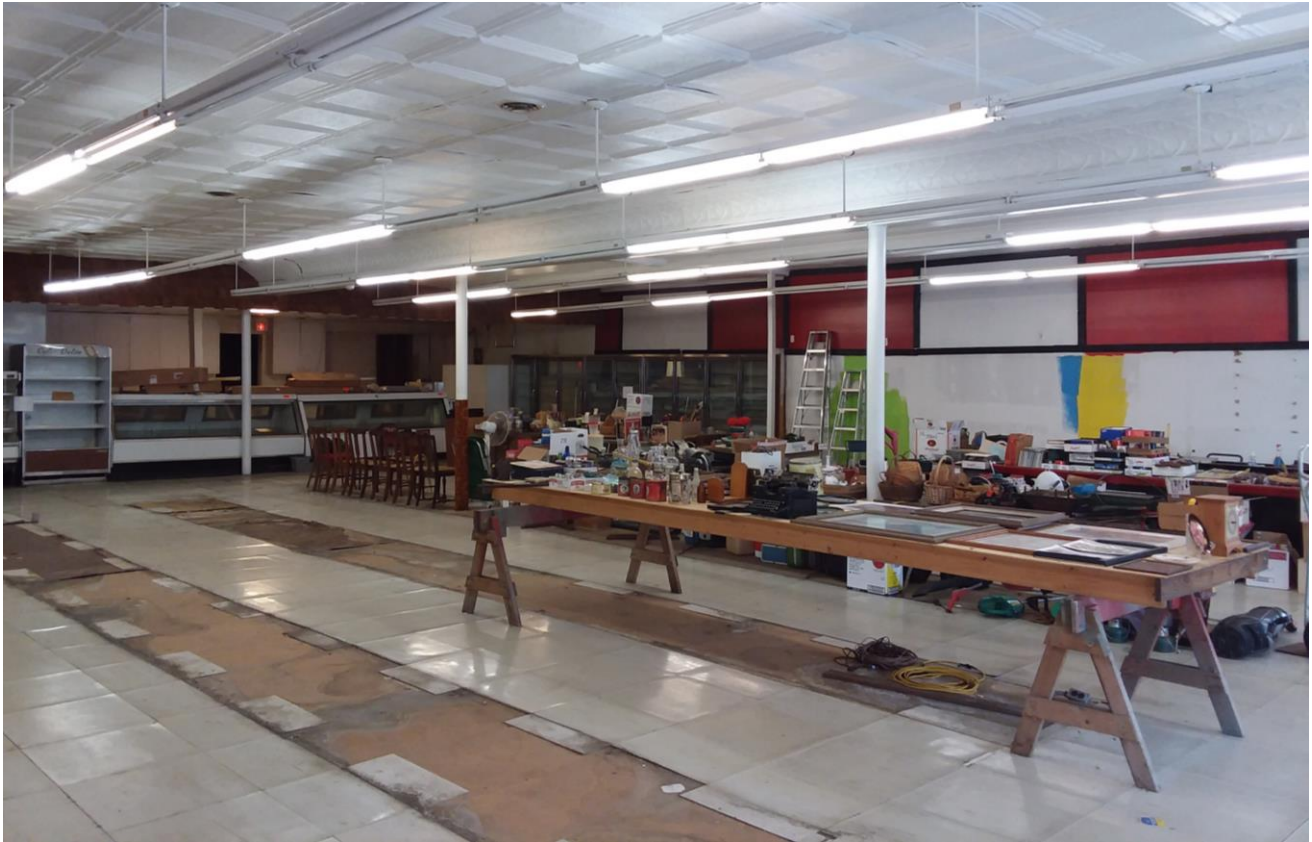
- a. The roof structure for the original building consisted of wood frame construction and a wood beamline near the center of the building. The center beamline beared on (3) steel columns and (1) 2x built up wood column. See photo #19.

Photo #19 – Interior beams and columns

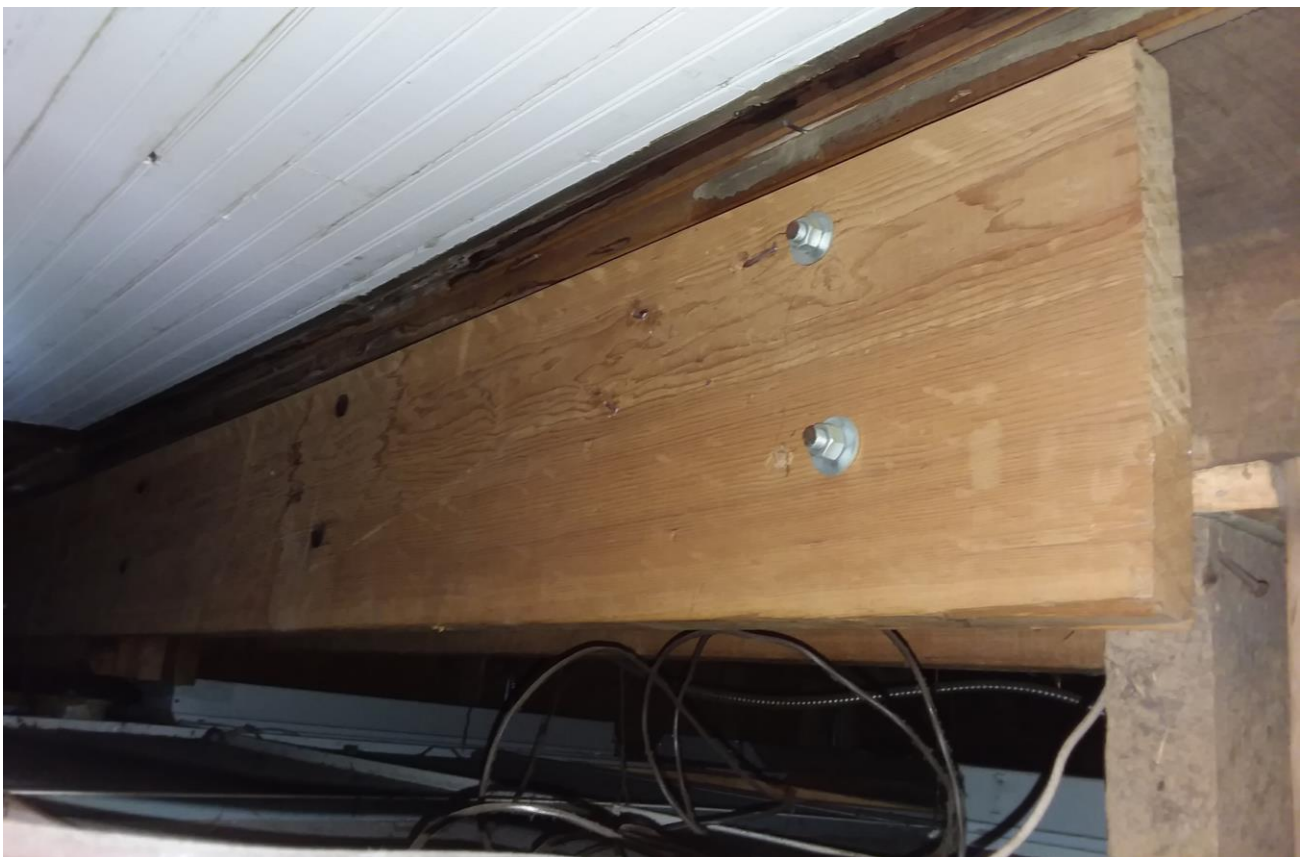
- b. The roof construction was able to be verified to be wood construction through a small access hole on the west side of the building.
- c. The wood beam above the suspended ceiling on the south end of the original building had been reinforced by bolting an additional wood member on each side of the existing beam. See photo #20.

- f. The observation of the roof structure was limited due to inadequate access to the attic space and the presence of finished materials. Based on the limited observation it appeared that the roof system had been reinforced in the past and portions of the roof may have experienced significant deflection over the life of the structure.

Photo #20 – Wood beam reinforcement
