CITY OF VERGAS, MINNESOTA

100,000 Gallon Capacity
Tower Number One

Elevated Water Tank Inspection Report

KLM Project
4300-21

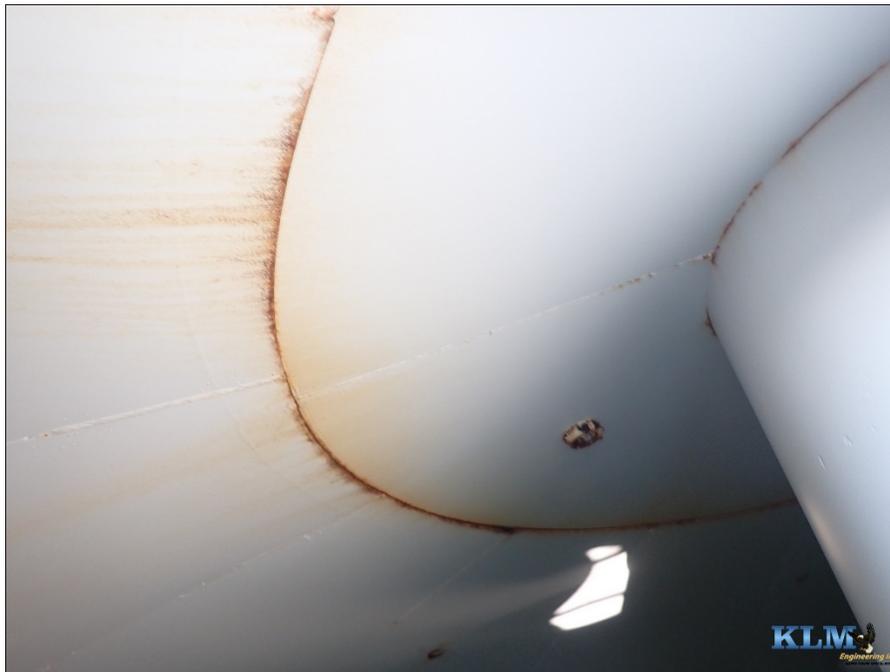
Photo No. 2
Dollar plate to drywell tube and roof plate, Note; rigging coupling

4.1.1 Seal weld the following joints. Seal welding these joints will prevent rust streaking and corrosion in areas inaccessible to paint. See photos 2 through 4.

4.4.6 Replace the two, 2-inch threaded rigging couplings with the same size unthreaded couplings with weathertight covers. See photos 2, 4, 37, and 41.

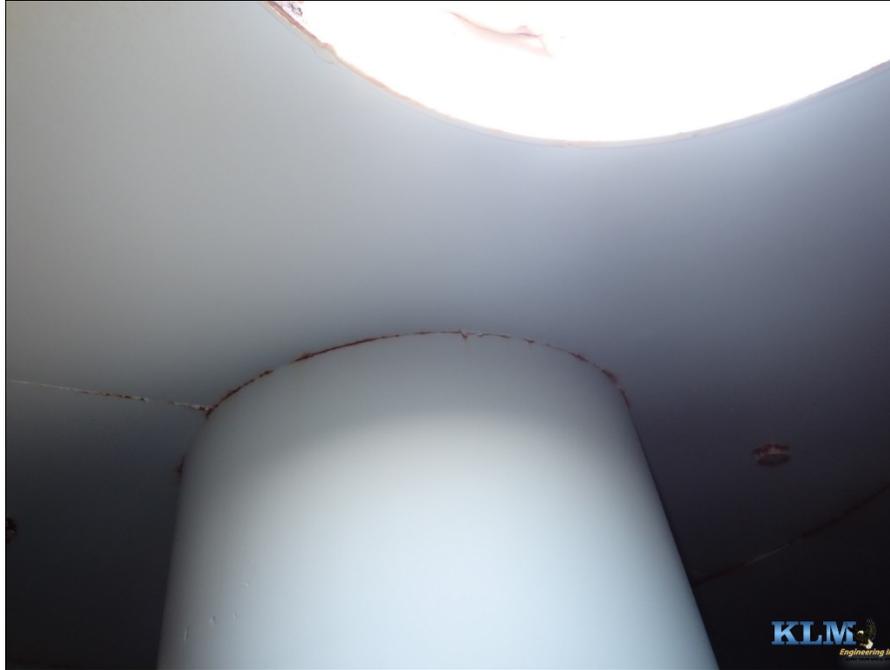
Photo No. 3
Drywell tube to roof connection

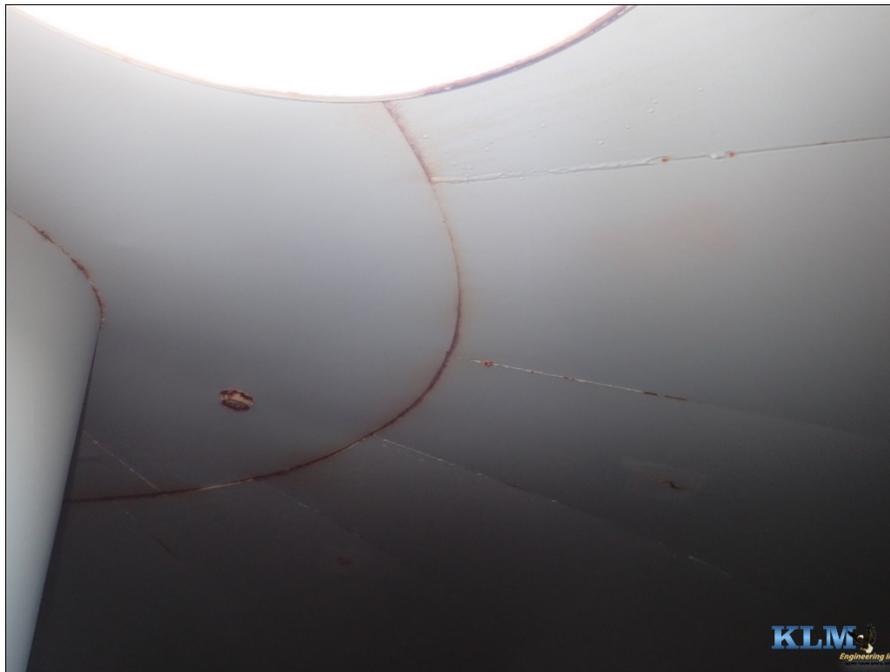
Photo No. 4
Dollar plate to drywell tube and roof plate, Note; rigging coupling

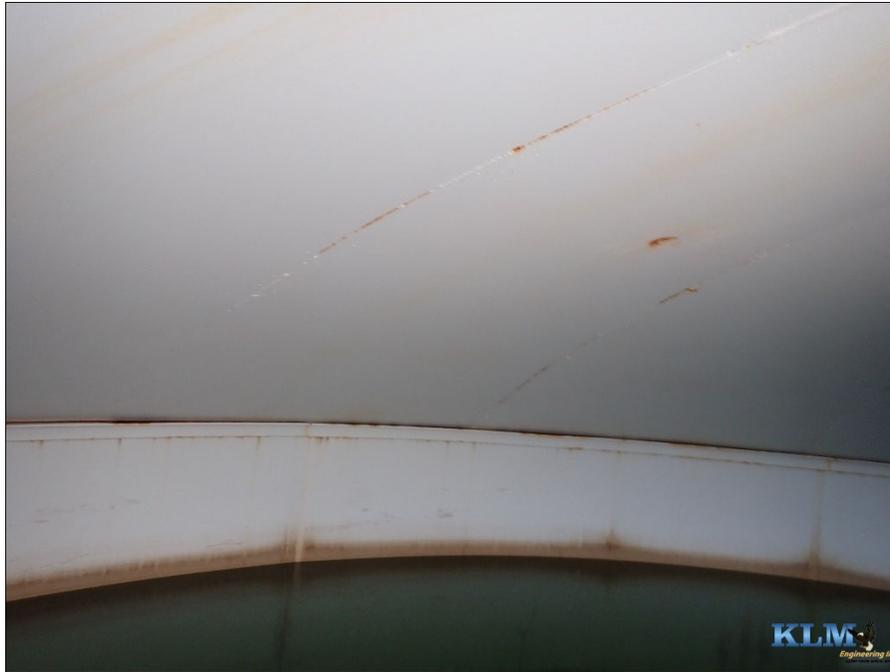
Photo No. 5
Roof condition and connection to shell

4.1.2 Epoxy caulk the shell to roof circumferential joint. Seal welding this joint is cost prohibitive, but the result is similar. See photos 5 through 7.

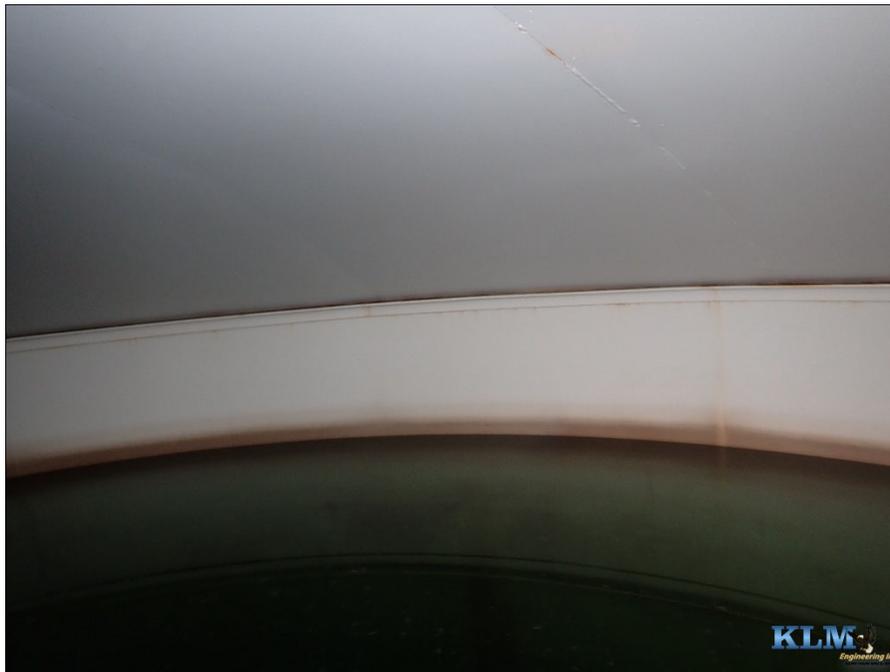
Photo No. 6
Roof condition and connection to shell

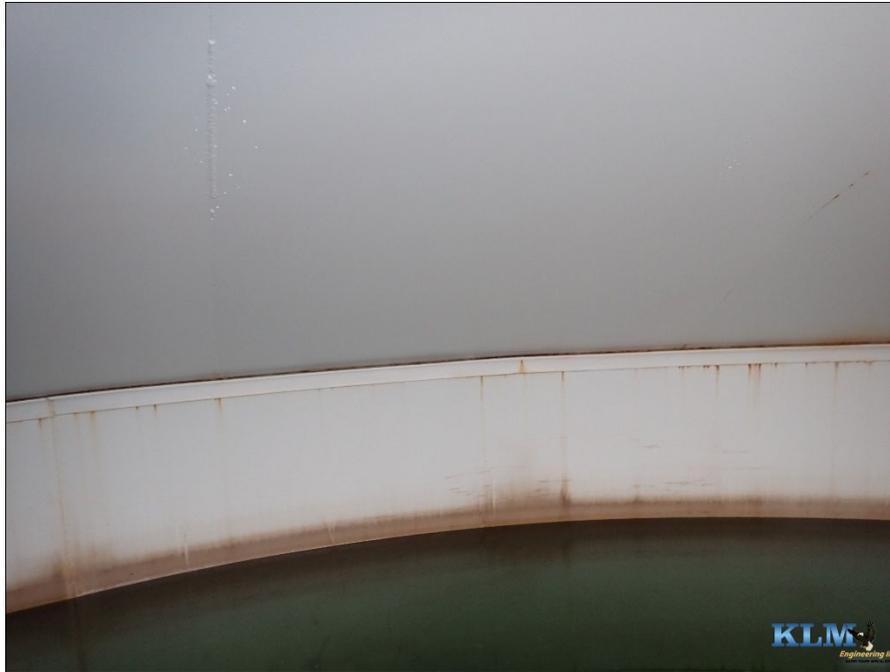
Photo No. 7
Roof condition and connection to shell

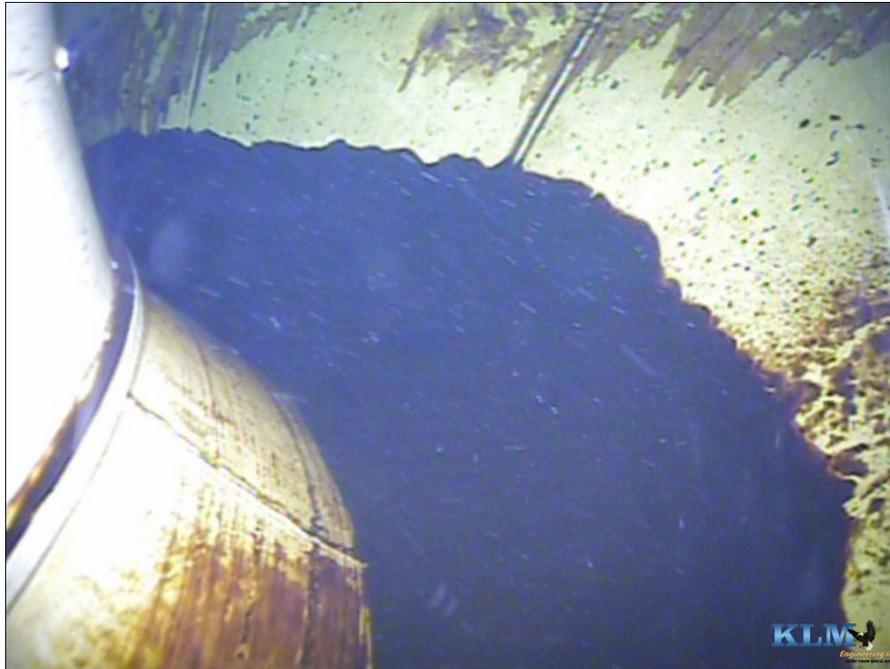
Photo No. 11
Sediment accumulation in bowl

Per the Service Agreement, the next inspection is a dry tank cleanout scheduled for 2026. Given the significant sediment accumulation, consider adjusting the schedule by performing a dry tank cleanout within the next twelve months. Not only will this clean up the reservoir but it will establish a benchmark for monitoring rate of accumulation and determine a routine for future cleanouts.

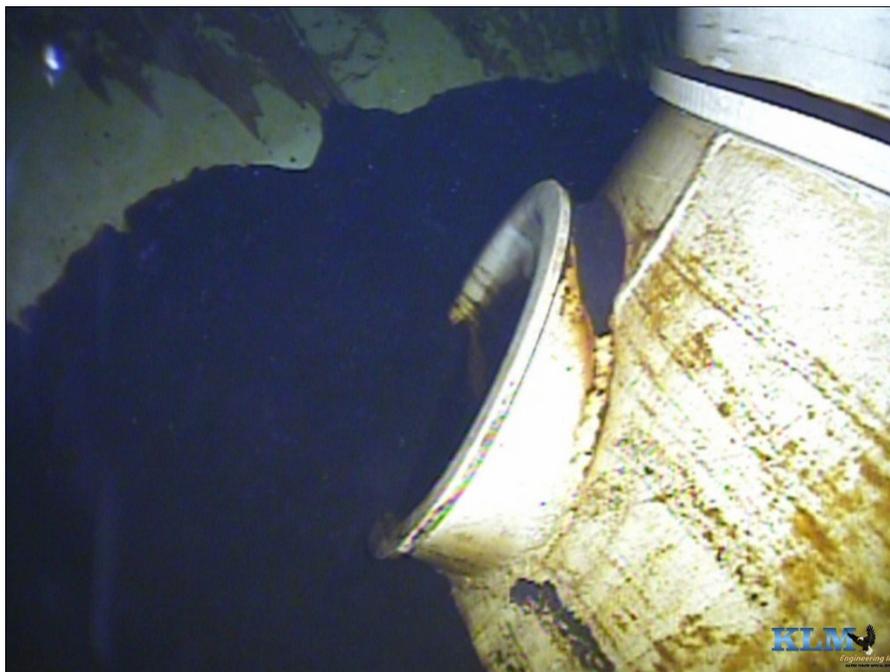
Photo No. 12
Sediment accumulation in bowl

4.1.3 Replace the gasket on the oval bowl manway. See photos 12 and 28.

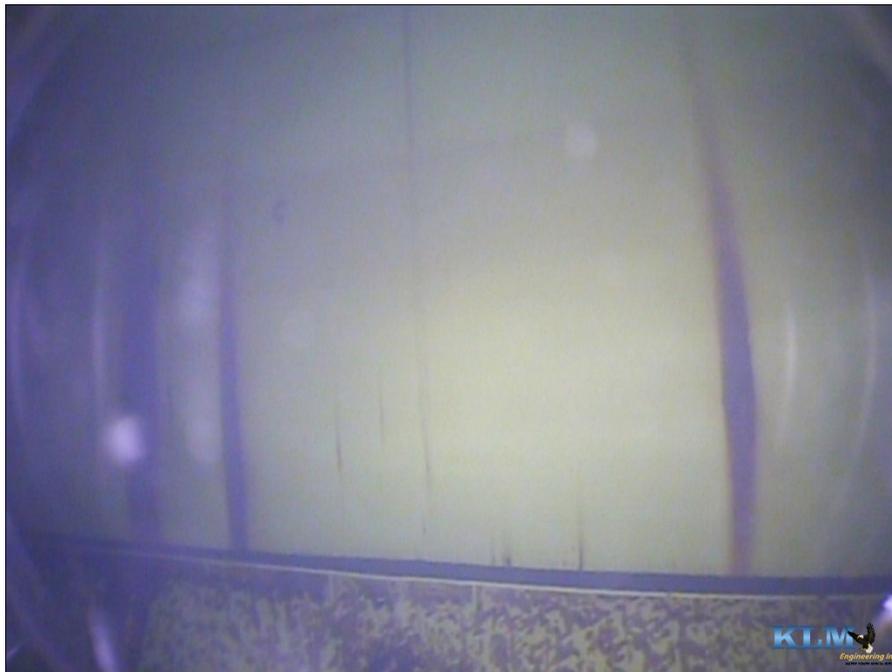
Photo No. 18
Corrosion on shell

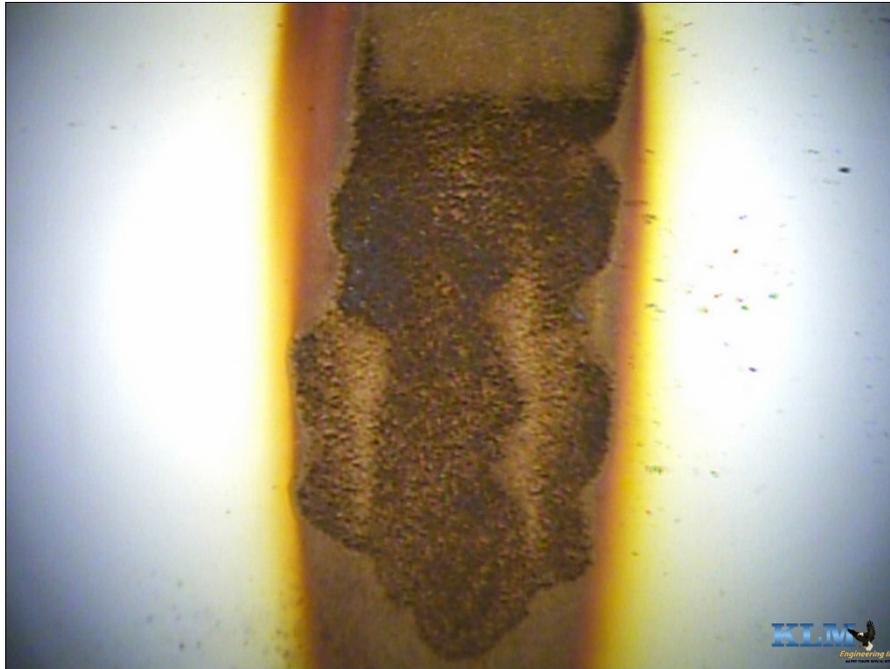
Photo No. 19
Corrosion on shell

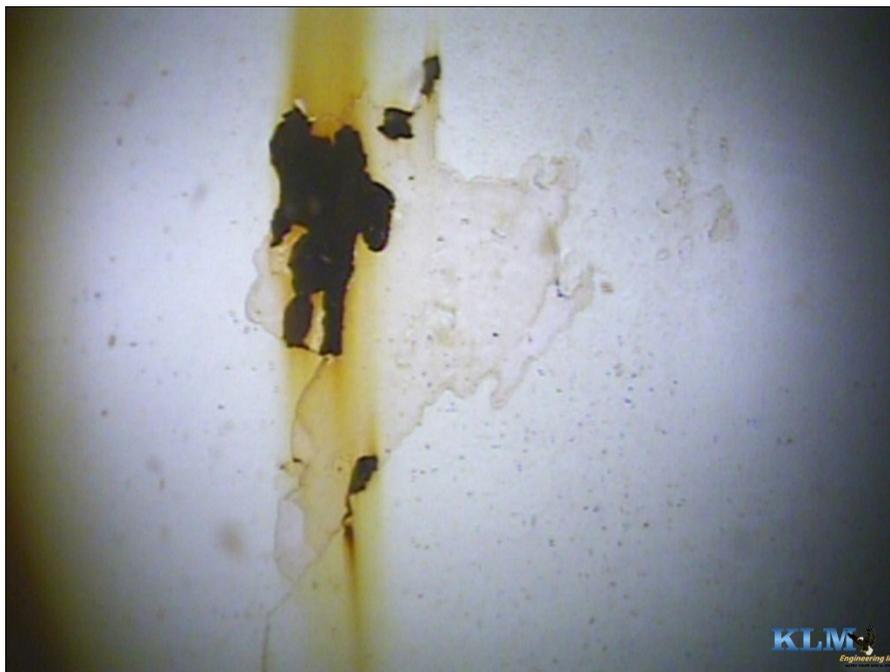
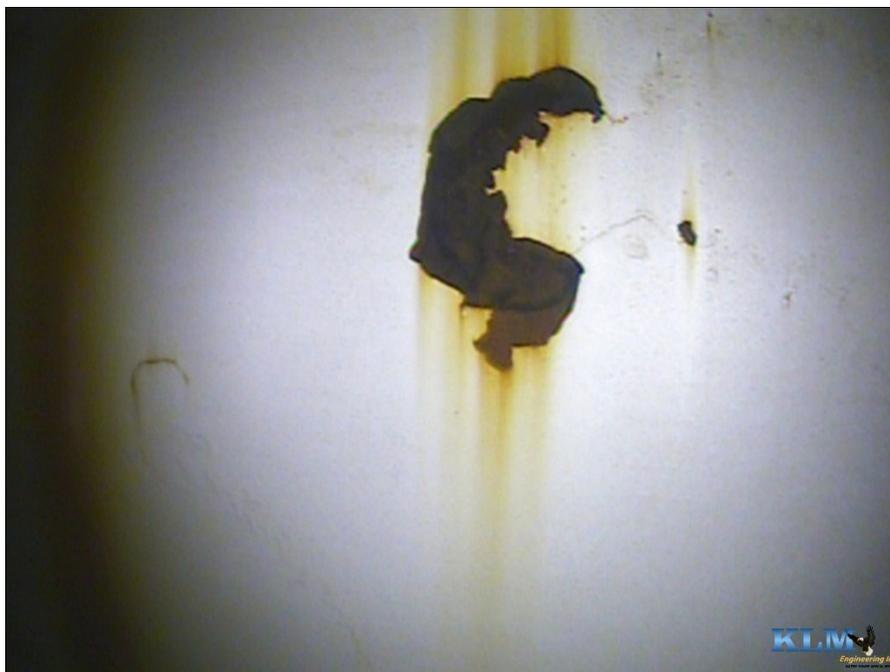
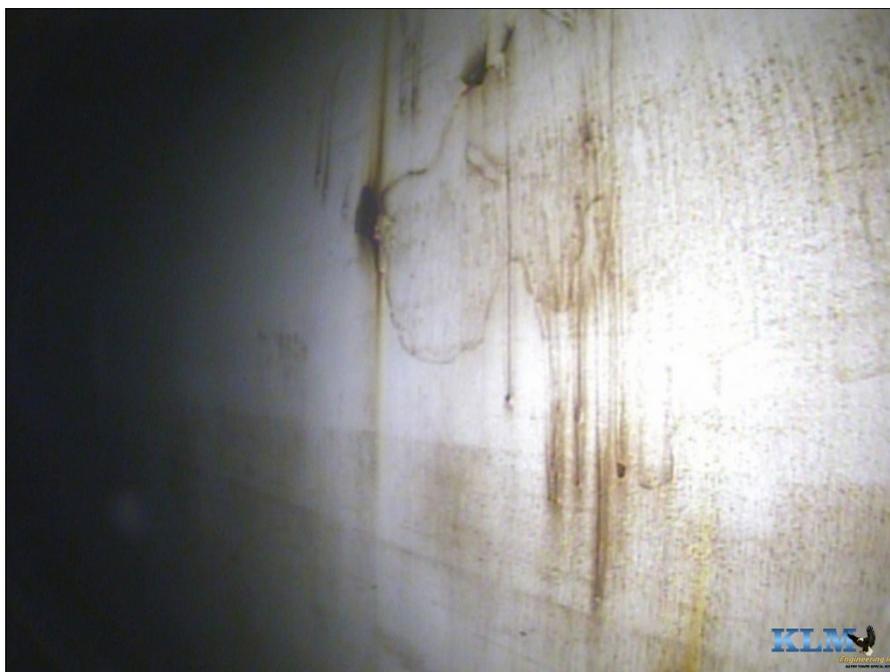
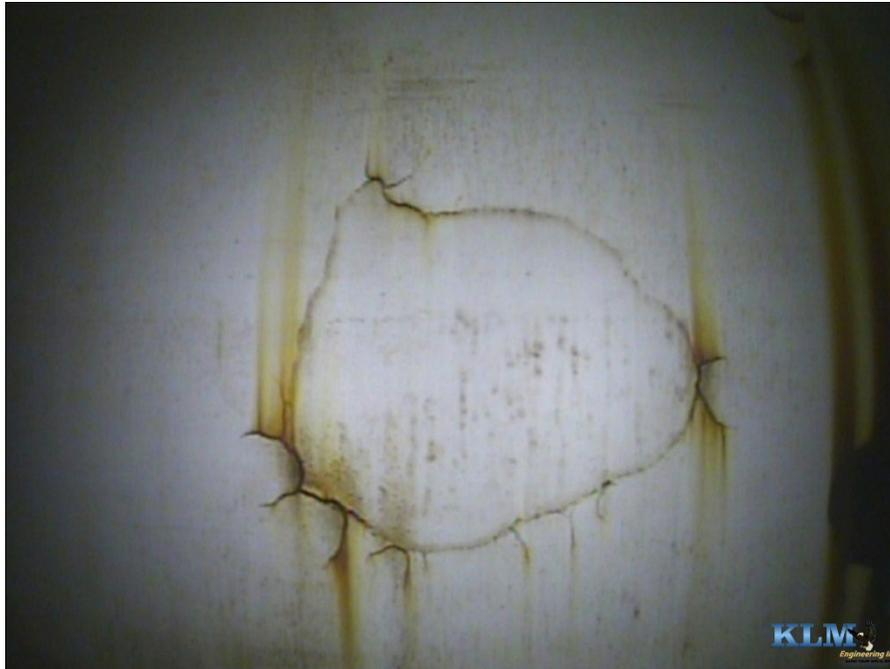
The tower was constructed, and the interior wet area originally coated, in 1993 by Caldwell Tank. According to Owner provided information, Maguire Iron fully reconditioned the interior wet area in 2007. The interior wet coating is in poor overall condition, with approximately five percent coating failures above the High-Water Line (HWL) and approximately 10 percent coating failures below the HWL. Failures above the HWL consist of corrosion along unwelded roof plate weld joints and rust nodules at random locations. Failures below the HWL consist of more widespread corrosion nodules on weld joints and random locations. Due to age and condition, the coating is not a candidate for repairs and should be replaced in its entirety within three years to maximize the life expectancy of the structure. See photos in Appendix A.

Photo No. 20
Coating failures and corrosion on shell, Note; indication of poor surface preparation during repairs

Photo No. 21
Coating failures and corrosion on shell, Note; indication of poor surface preparation during repairs

Photo No. 22
Coating failures and corrosion on shell, Note; indication of poor surface preparation during repairs

Photo No. 23
Coating failures and corrosion on shell, Note; indication of poor surface preparation during repairs

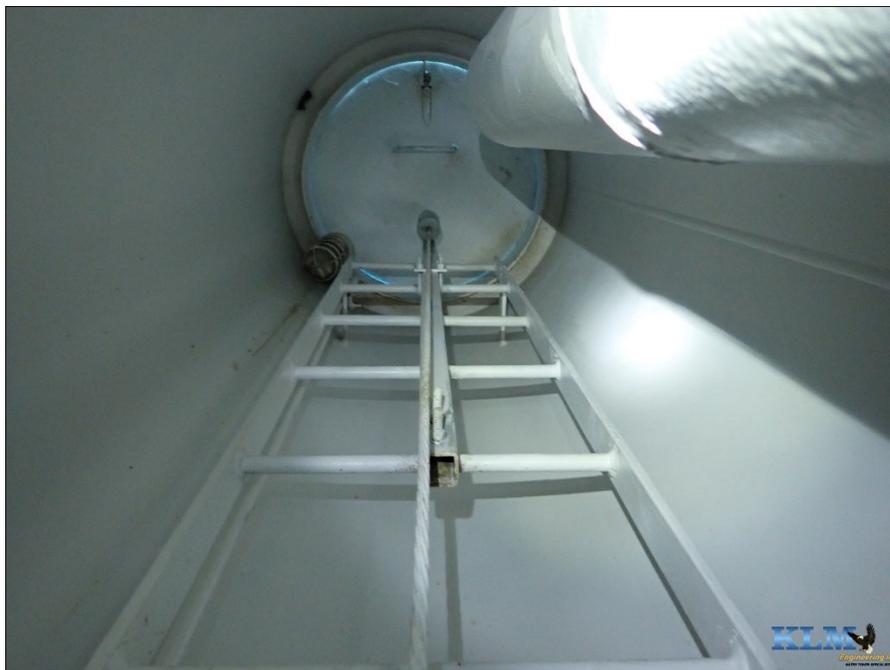
Photo No. 24
Top of drywell tube (looking up)

4.3.2 Replace the cable style safety climb devices on the ladders. The existing cables have been painted and are not deemed OSHA compliant. See photos 24, 30, and 31.

4.3.6 Replace the light fixtures with LED fixtures. See photos 24, 28, and 29.

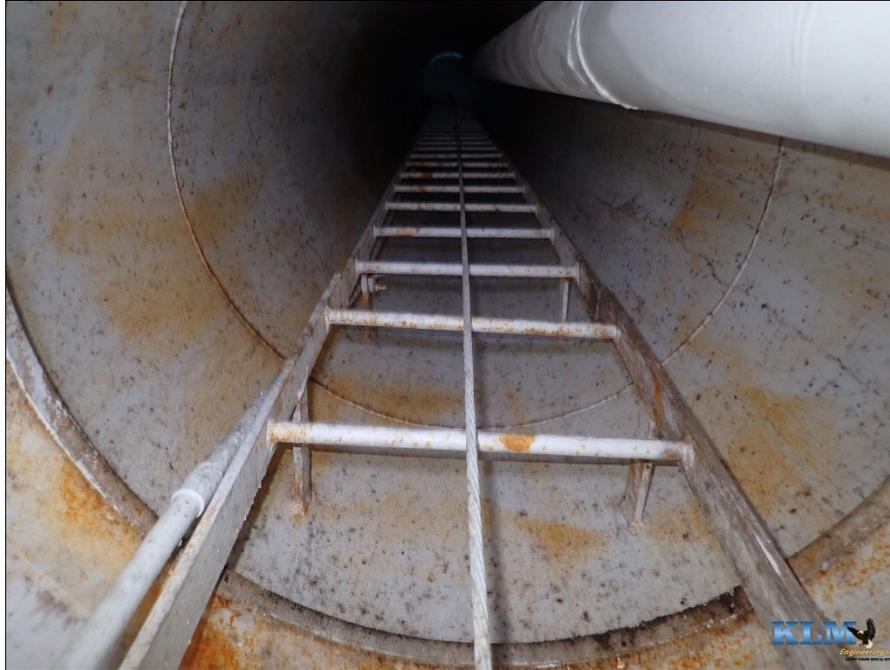
Photo No. 25
Lower section of the drywell tube

4.3.4 Install approximately six (6) half-moon cable brackets inside the drywell tube, equally spaced, for the attachment of electrical and coaxial cables. See photo 25.

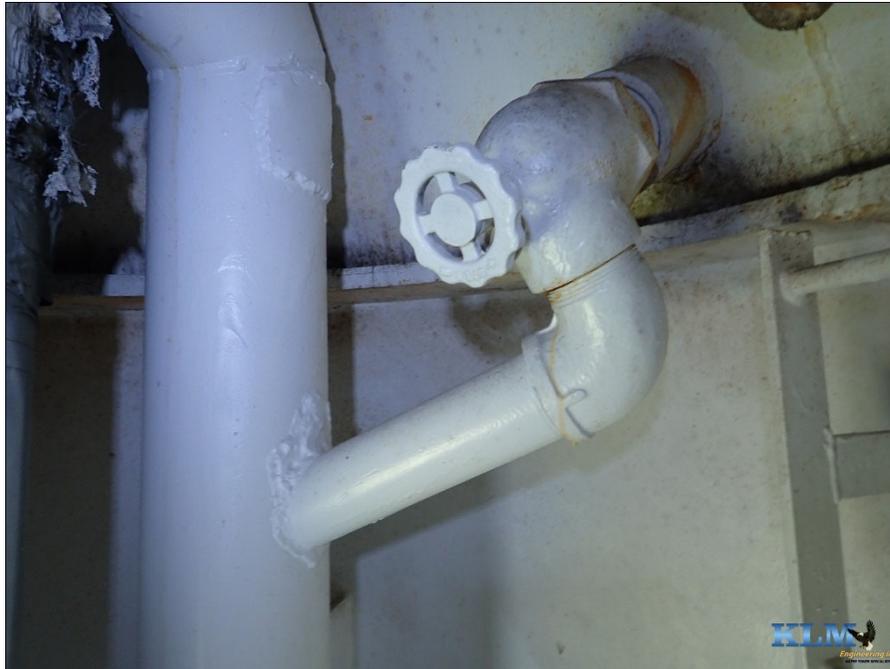
Photo No. 27
Bowl drain cleanout

4.3.3 Replace the existing bowl drain valve with a stainless-steel valve similar to those designed by Babco Company. Include a clear, rigid, high pressure hose connected to the overflow pipe. Include the replacement of the coupling in the bowl with a ½ coupling. This facilitates cleaning and draining the bowl below the inlet pipe level. See photo 27.

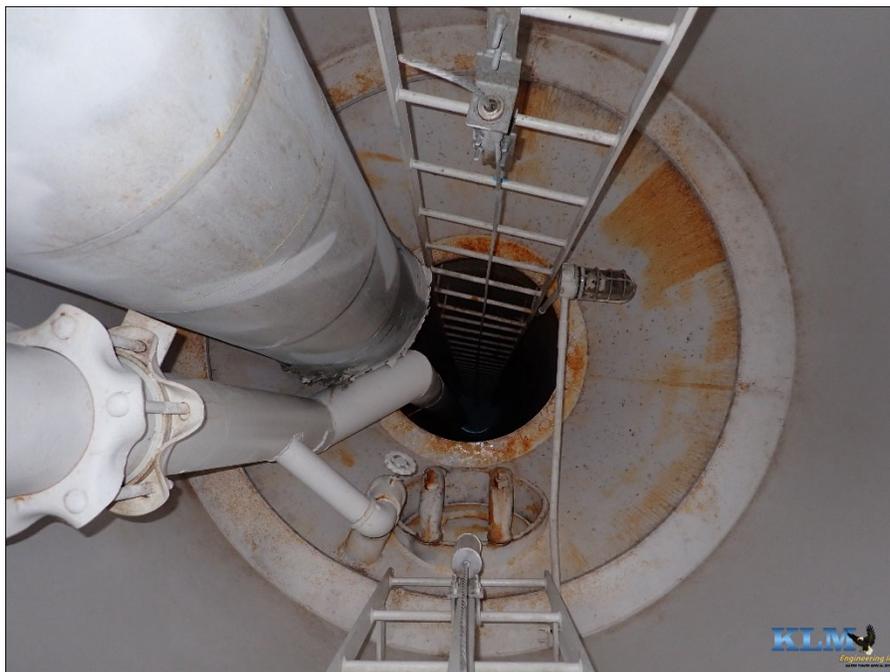
Photo No. 28
Overall condition of bowl

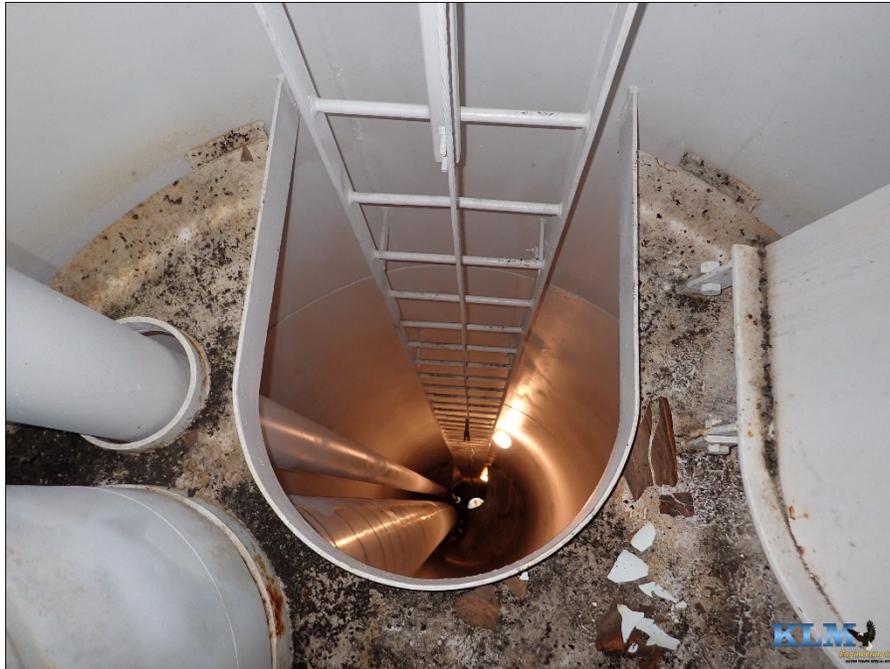
Photo No. 29
Top landing

4.3.1 Convert the top landing of the riser into a condensate ceiling by adding a ¼-inch by 2.5-inch flat bar and seal welding the perimeter to the pedestal. Install a drain in the low point of the landing with a connecting line to the overflow pipe. This will prevent condensation from running down the pedestal,

exacerbating defects in the coating, and leading to corrosion and additional painting and maintenance costs. See photos 29 and 30.

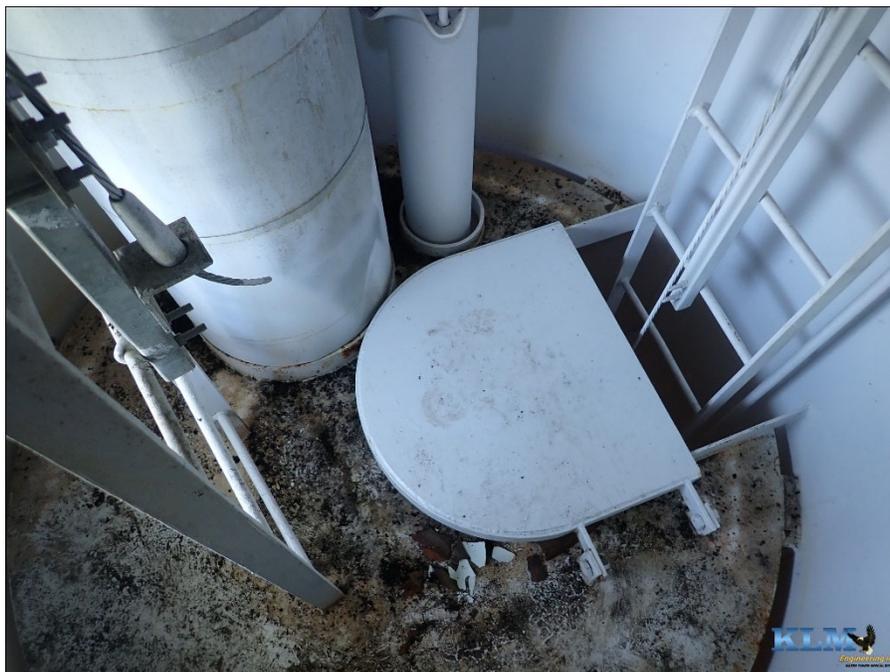
Photo No. 30
Top landing

4.3.7 Install ports in the center of the upper two platform floors to facilitate containment during the next reconditioning. See photos 30 and 31.

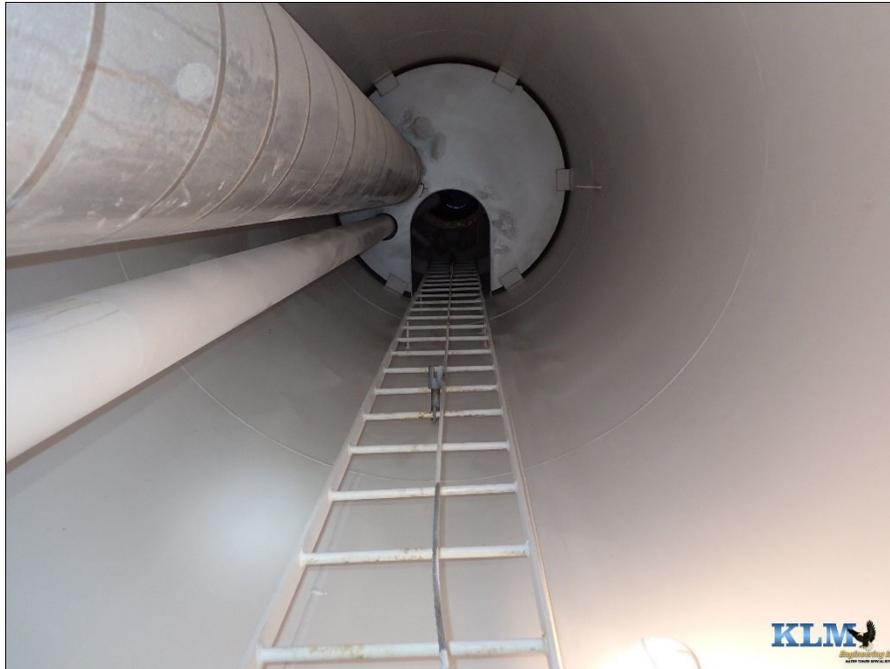
Photo No. 31
Overall conditions in riser (looking up)

4.3.5 Install approximately ten (10) pedestal stand-off brackets in the pedestal at 8-foot maximum spacing for the mounting of the electrical and coaxial cables. Move the electrical conduits along the ladders to the stand-off bracket to bring the ladders into OSHA compliance. See photos 31, 32 and 34.

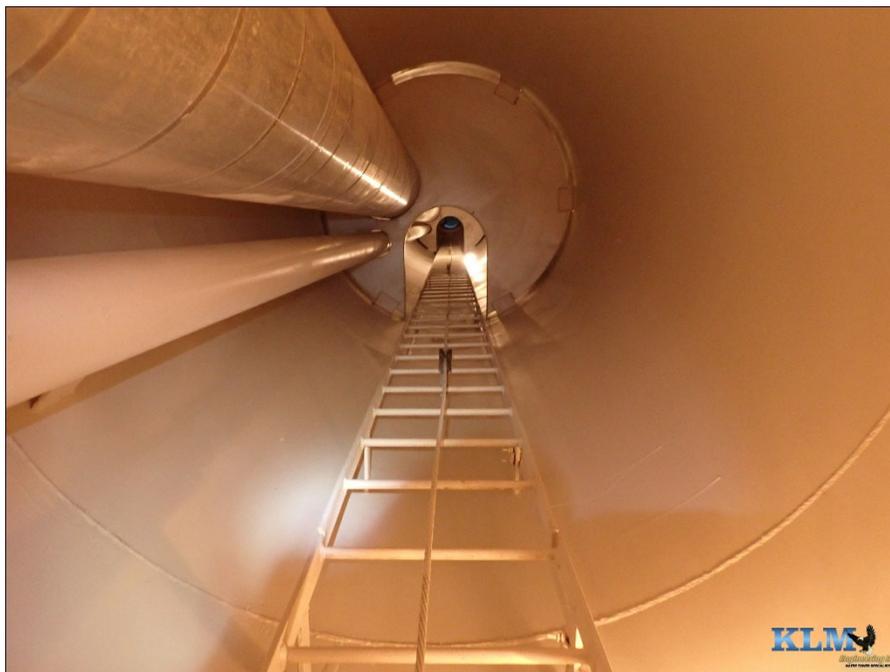
Photo No. 32
Conditions in riser (looking up)

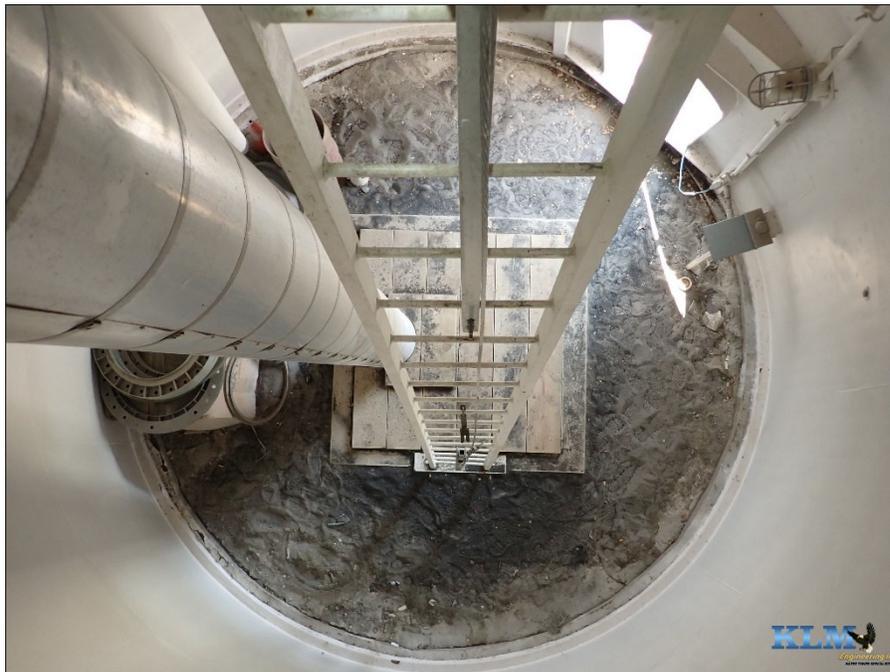
Photo No. 34
Base cone conditions (looking down)

4.3.8 Install a 4-inch-thick concrete pad in the base of the tower at grade, flush with the top of the existing ring wall foundation. Some of the existing soil will require removal. The concrete slab shall be reinforced with 6 x 6 – W1.4/W1.4 welded wire fabric, graded, float finished flat and level. See photos 34 and 35.

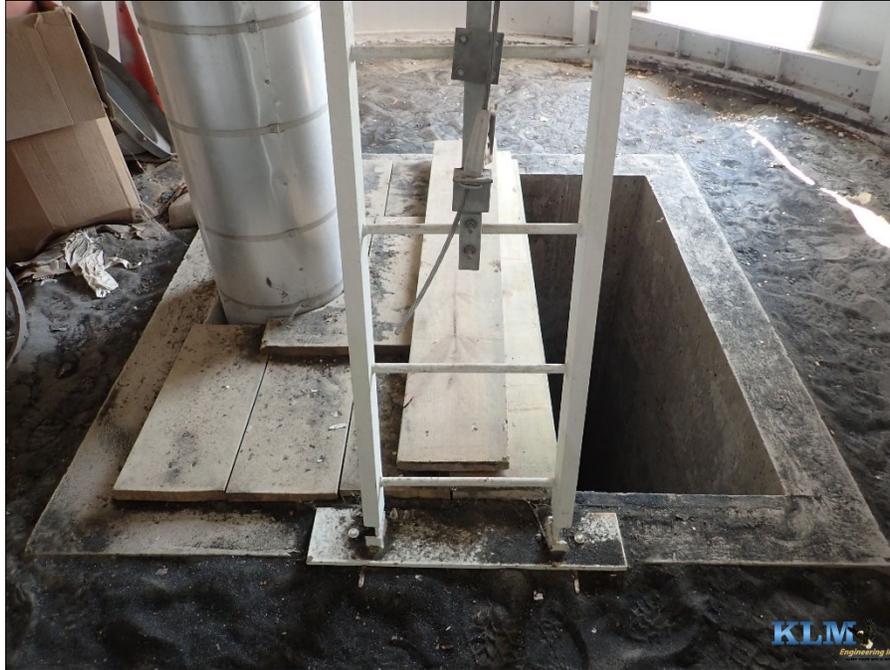
Photo No. 35
Valve pit

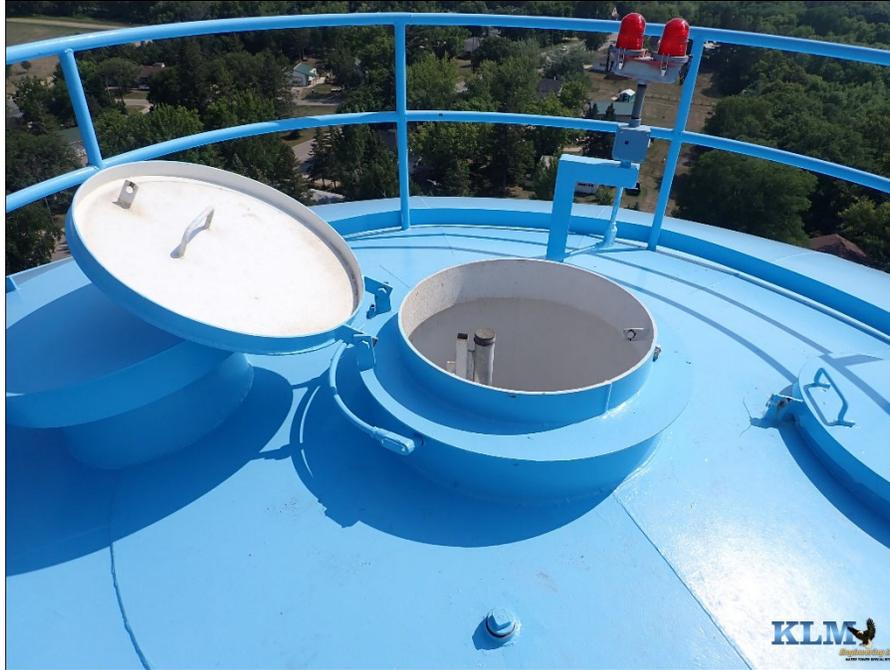
Photo No. 37
Overall conditions on roof

4.4.1 Install an anchor point on the exterior (roof side) of the drywell tube for securing safety harnesses with lanyards during egress from the drywell and transitioning from the drywell tube safety climb device to the tower roof. See photo 37.

4.4.2 Replace the drywell tube manway cover with an aluminum cover and stop chain. This make lifting the larger cover easier and limit the angle of travel of the cover, (prevent the cover from opening 180 degrees). See photo 37.

4.4.5 Replace the double aviation light with a new double LED style aviation light similar to Hughey & Phillips L-810. See photo 37.

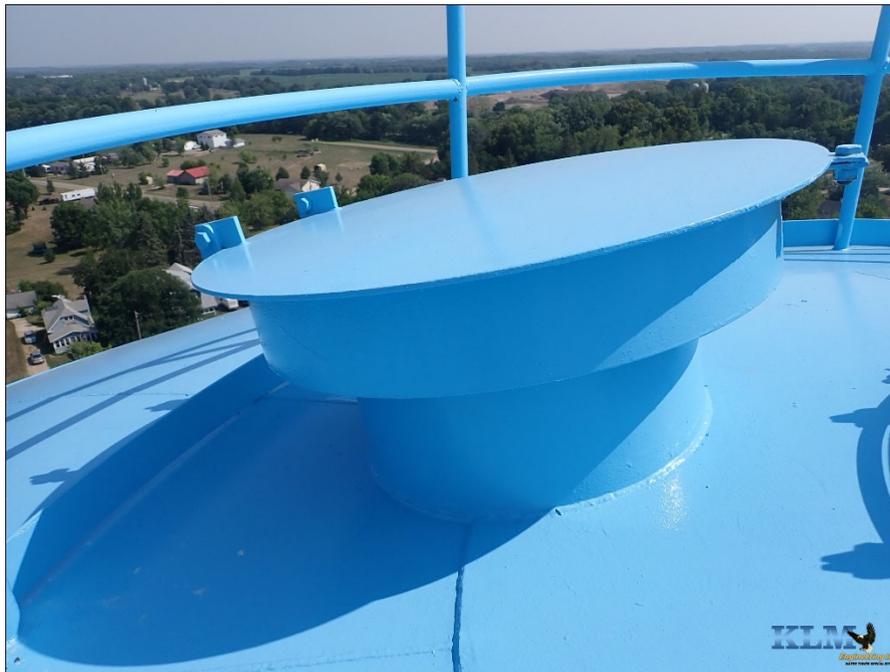
Photo No. 38
Finial vent

4.4.3 Replace the tank finial vent with a 24-inch diameter aluminum pressure pallet style vent. The new vent and vent screen design should meet AWWA D100-11 and Department of Health regulations. The removable top will improve ventilation, provide access to the tank interior during reconditioning, and aid in compliance with OSHA Confined Space Entry Requirements. See photo 38.

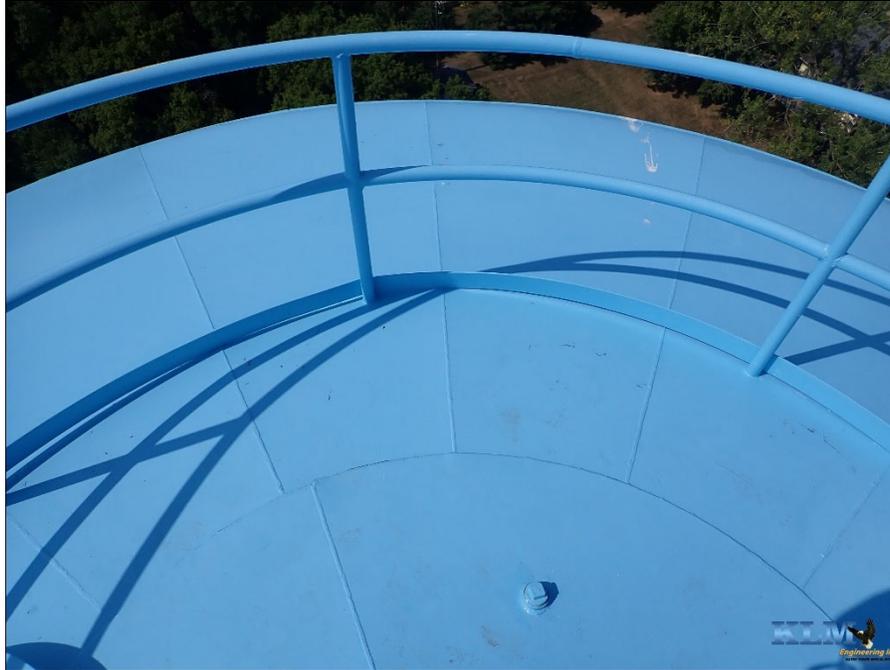
Photo No. 41
Roof coating conditions

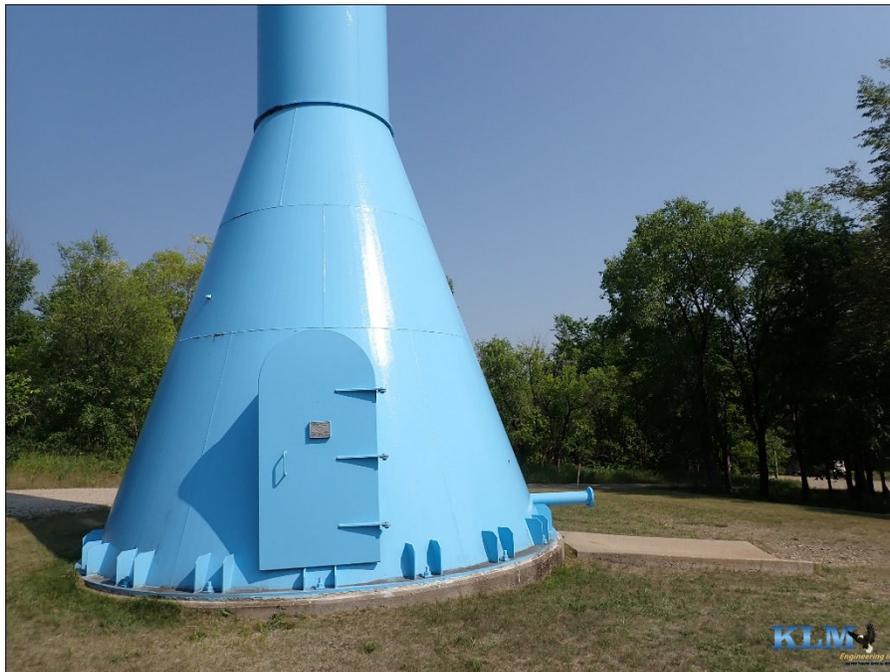
Photo No. 46
Overall condition of base cone

4.4.8 Urethane caulk around the perimeter of the base cone where it meets the concrete foundation. This will prevent water intrusion and corrosion along that seam. See photos 46 and 49.

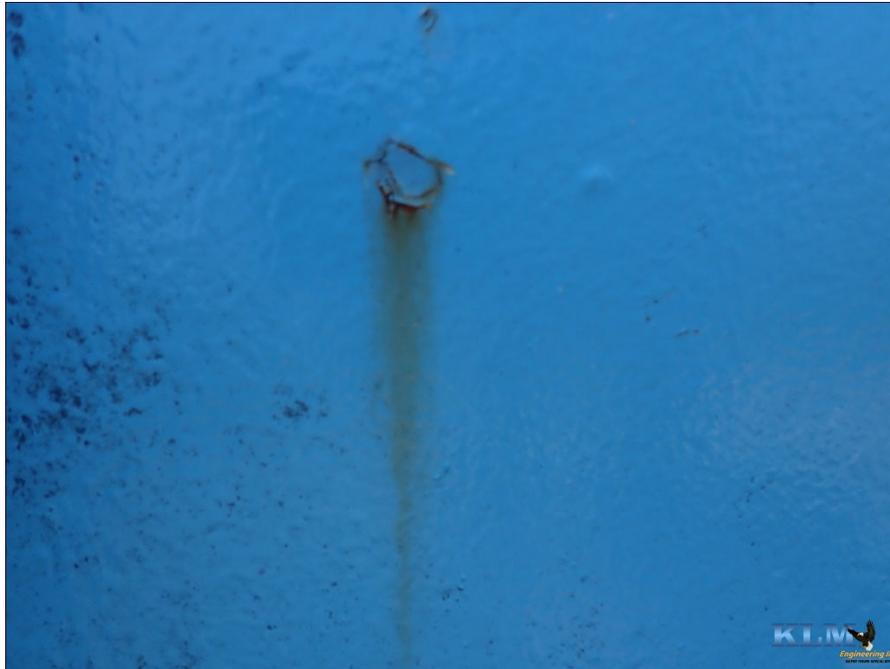
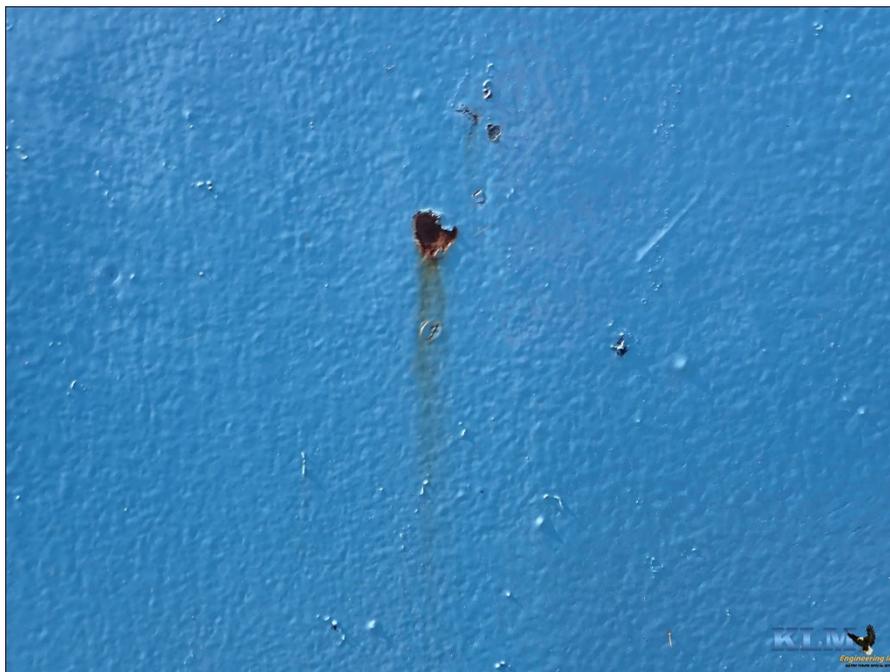
Photo No. 47
Isolated corrosion on base cone

Photo No. 48
Isolated corrosion on base cone

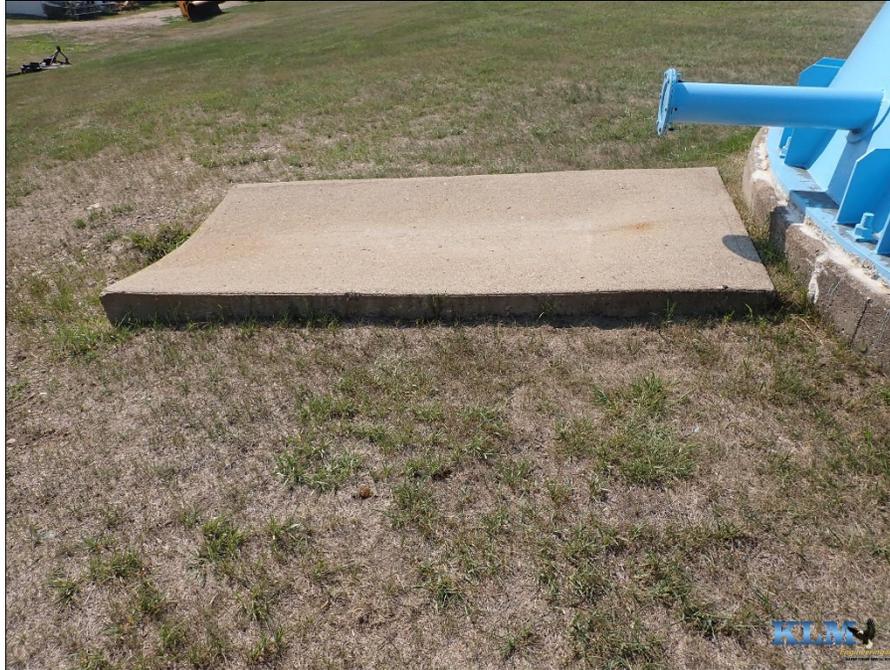
Photo No. 49
Overflow and splash pad

4.4.7 Per Minnesota Department of Health, modify the overflow discharge pipe outlet by installing a downward bend on the end and replace the existing overflow pipe screen with a corrosion-resistant, heavy-gauge #24 mesh screen. See photo 49.
