CITY OF VERGAS, MINNESOTA

100,000 Gallon Capacity
Tower Number One

Elevated Water Tank Inspection Report

KLM Project
4300-21

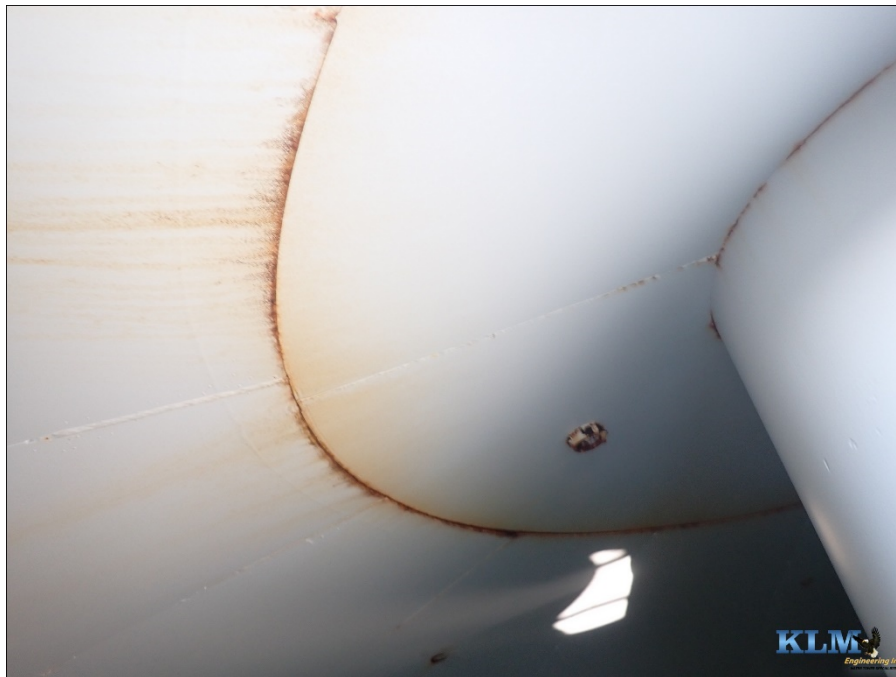
Photo No. 2
Dollar plate to drywell tube and roof plate, Note; rigging coupling

4.1.1 Seal weld the following joints. Seal welding these joints will prevent rust streaking and corrosion in areas inaccessible to paint. See photos 2 through 4.

- a. The overlap joint between the dollar plate and roof plates,
- b. The inside joint between the drywell tube and the dollar plate,
- c. The inside of the dollar plate butt joint,
- d. The inside joint between the wet access manway and the dollar plate.

4.4.6 Replace the two, 2-inch threaded rigging couplings with the same size unthreaded couplings with weathertight covers. See photos 2, 4, 37, and 41.

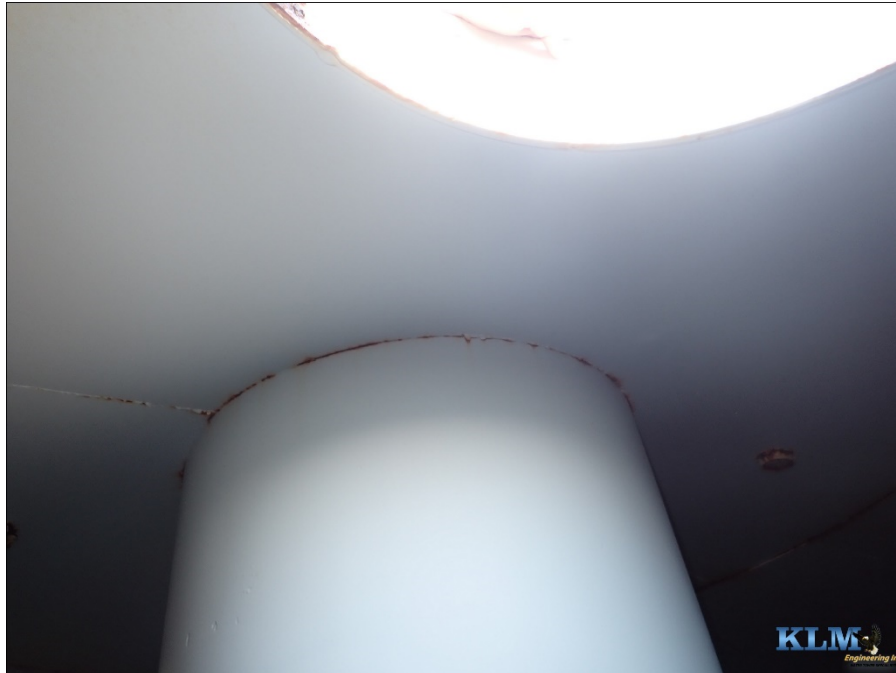
Photo No. 3
Drywell tube to roof connection

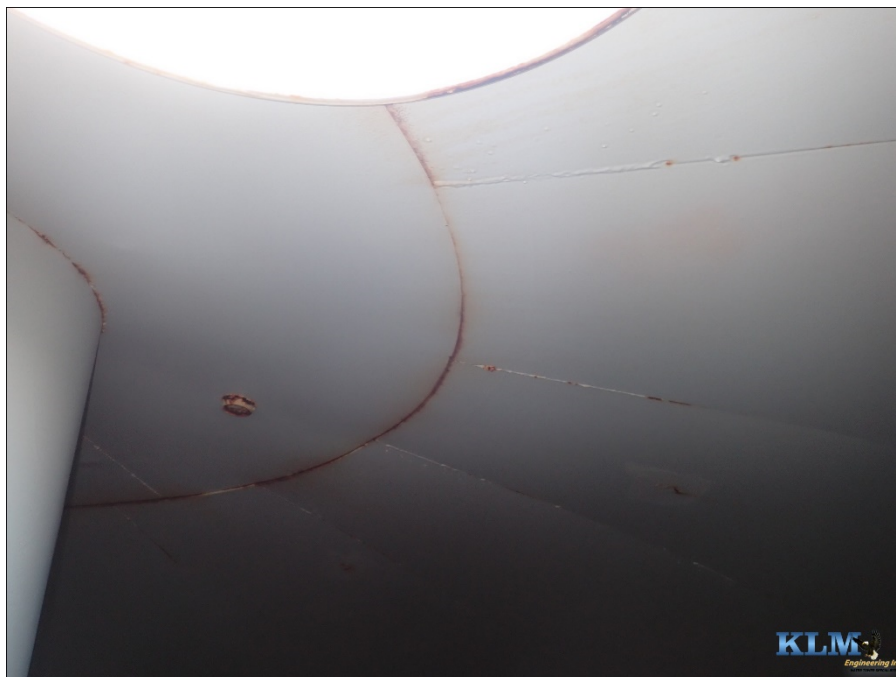
Photo No. 4
Dollar plate to drywell tube and roof plate, Note; rigging coupling

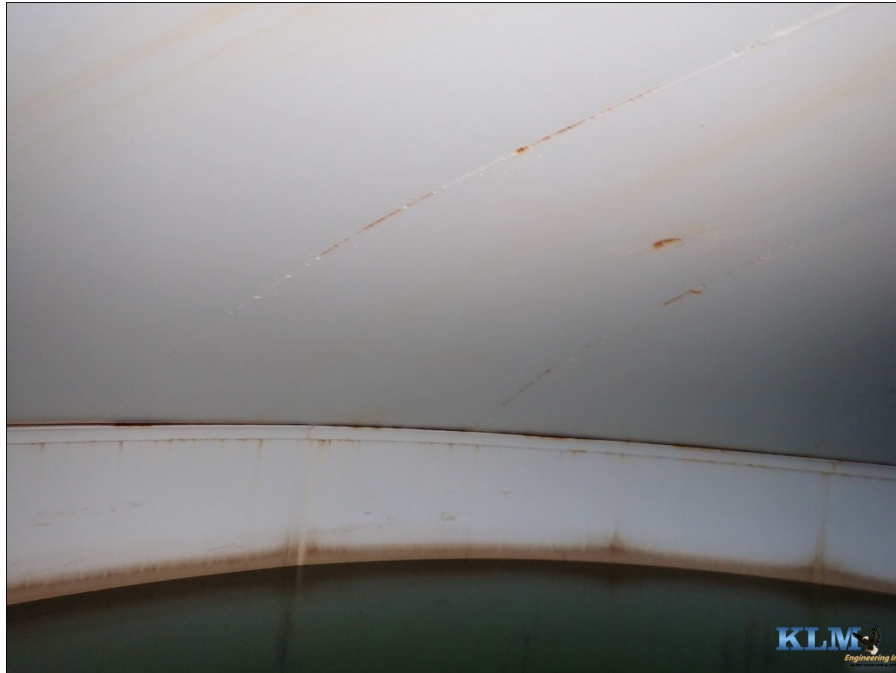
Photo No. 5
Roof condition and connection to shell

4.1.2 Epoxy caulk the shell to roof circumferential joint. Seal welding this joint is cost prohibitive, but the result is similar. See photos 5 through 7.

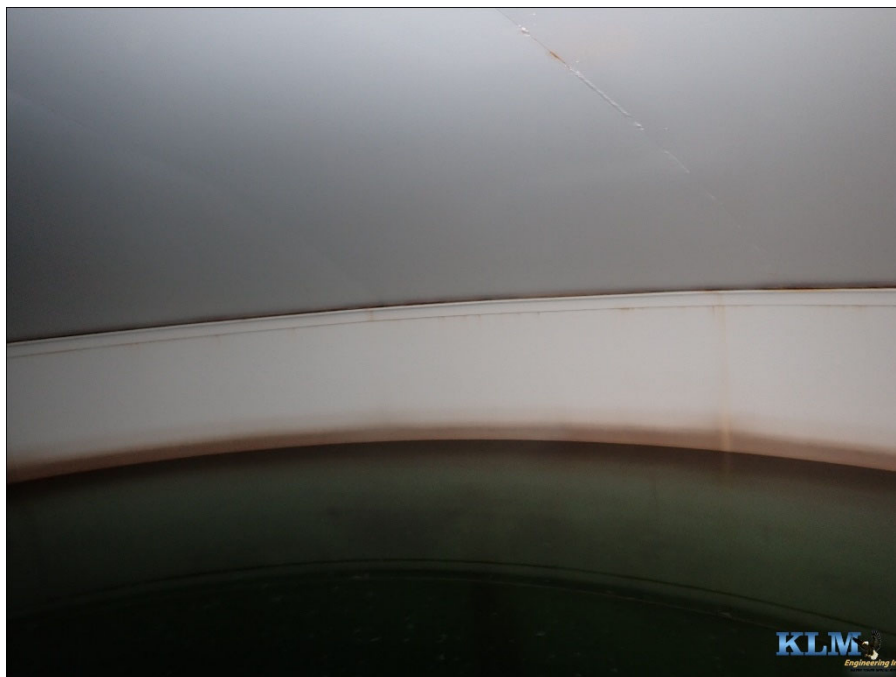
Photo No. 6
Roof condition and connection to shell

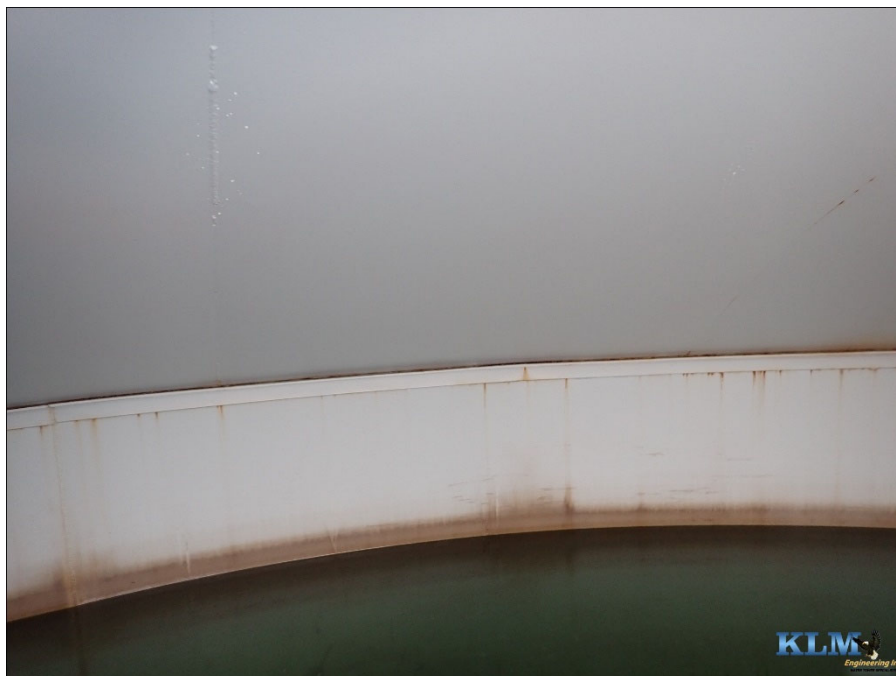
Photo No. 7
Roof condition and connection to shell

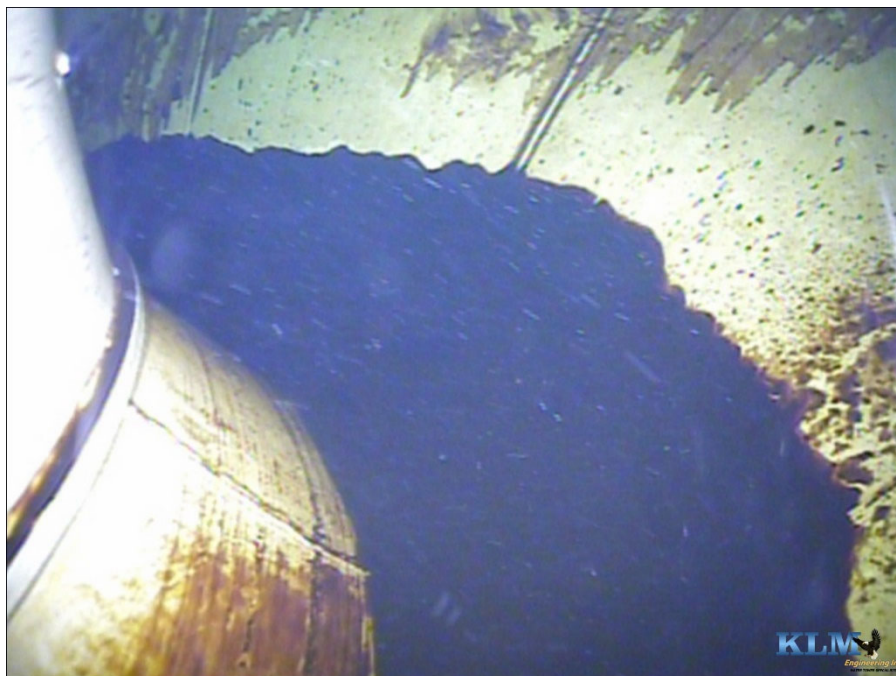
Per the Service Agreement, the next inspection is a dry tank cleanout scheduled for 2026. Given the significant sediment accumulation, consider adjusting the schedule by performing a dry tank cleanout within the next twelve months. Not only will this clean up the reservoir but it will establish a benchmark for monitoring rate of accumulation and determine a routine for future cleanouts.

Photo No. 11
Sediment accumulation in bowl

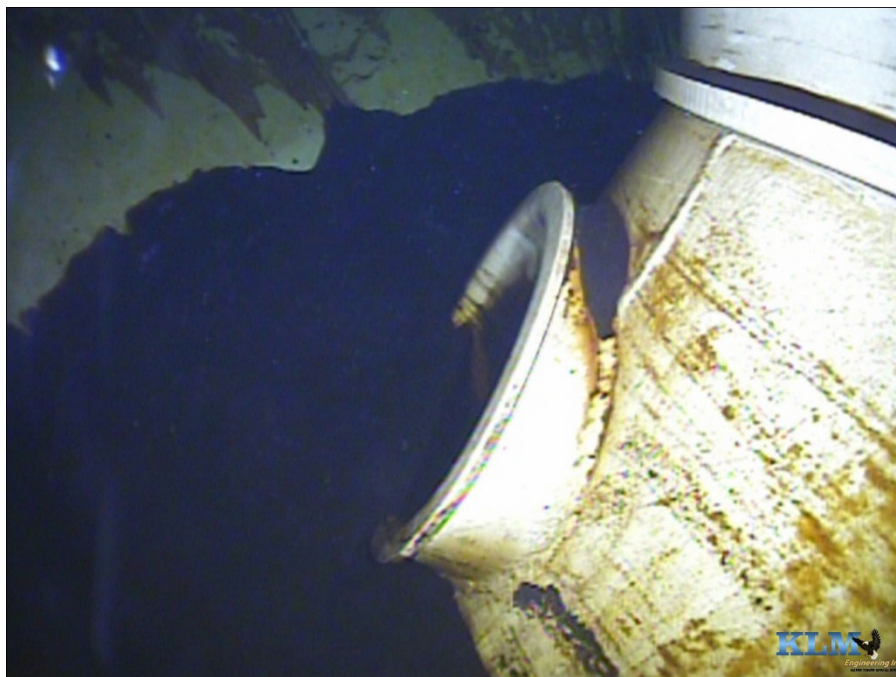
Photo No. 12
Sediment accumulation in bowl

4.1.3 Replace the gasket on the oval bowl manway. See photos 12 and 28.

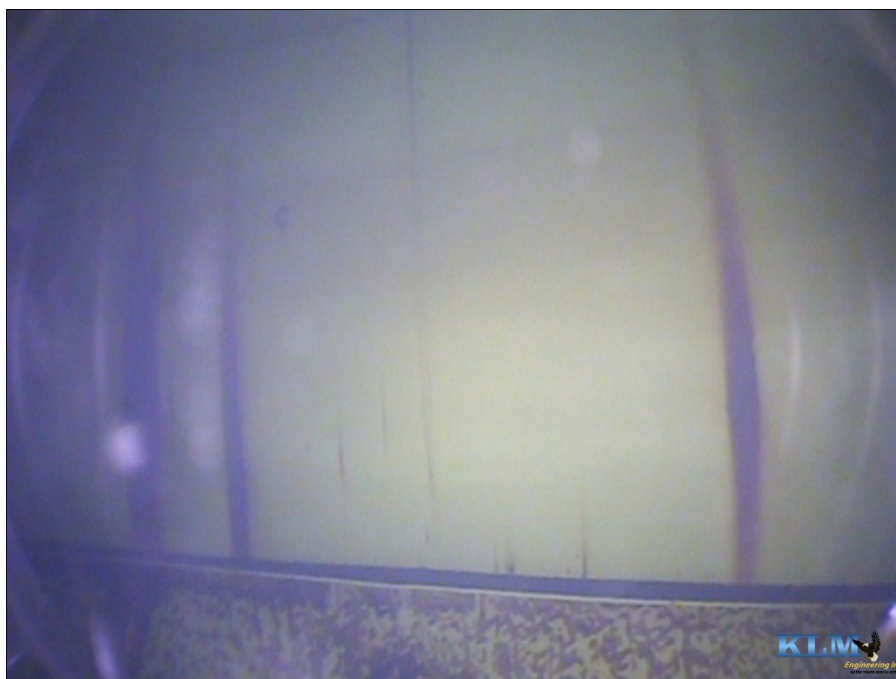
Photo No. 18
Corrosion on shell

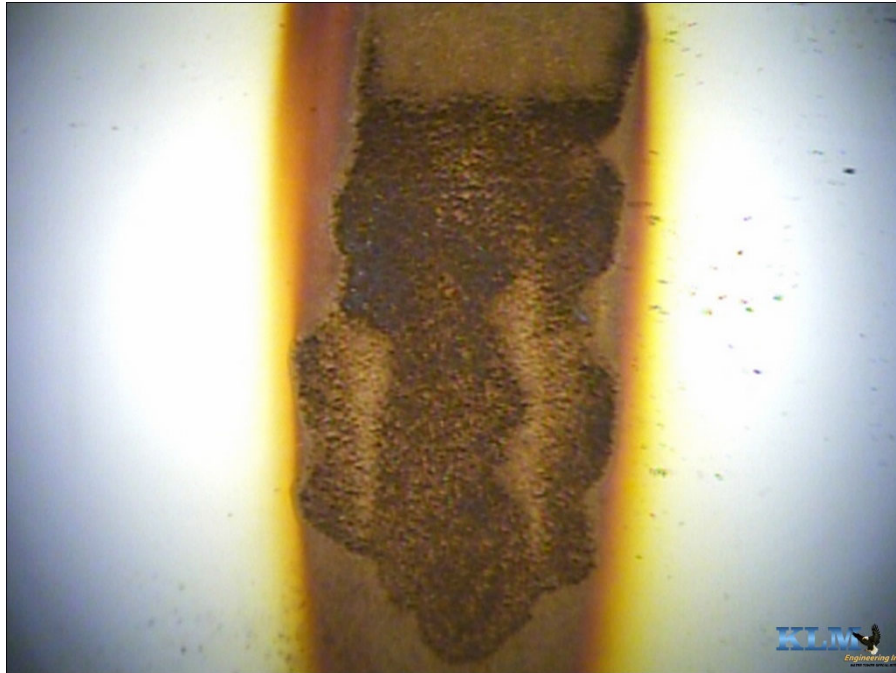
Photo No. 19
Corrosion on shell

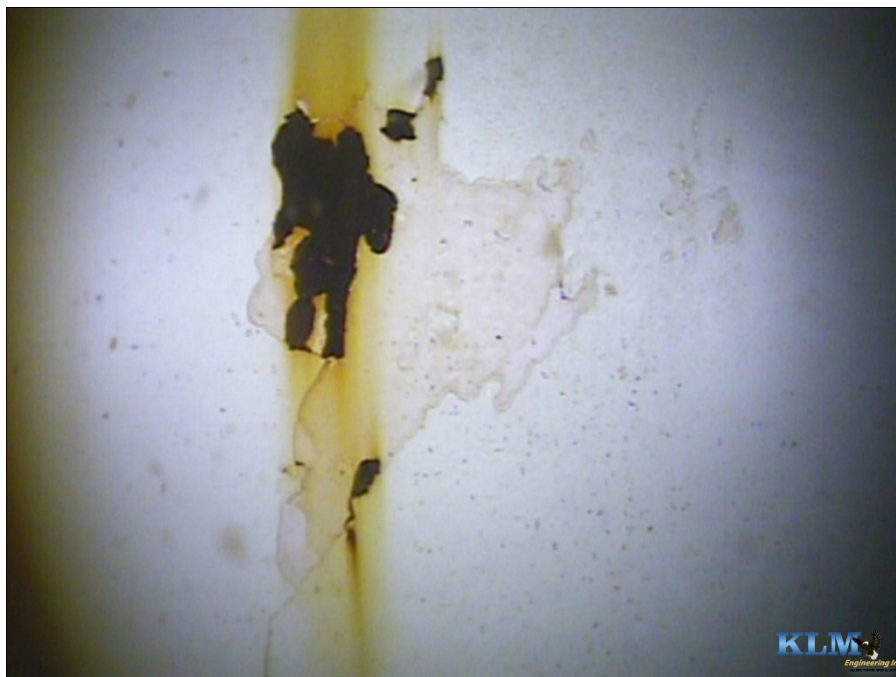
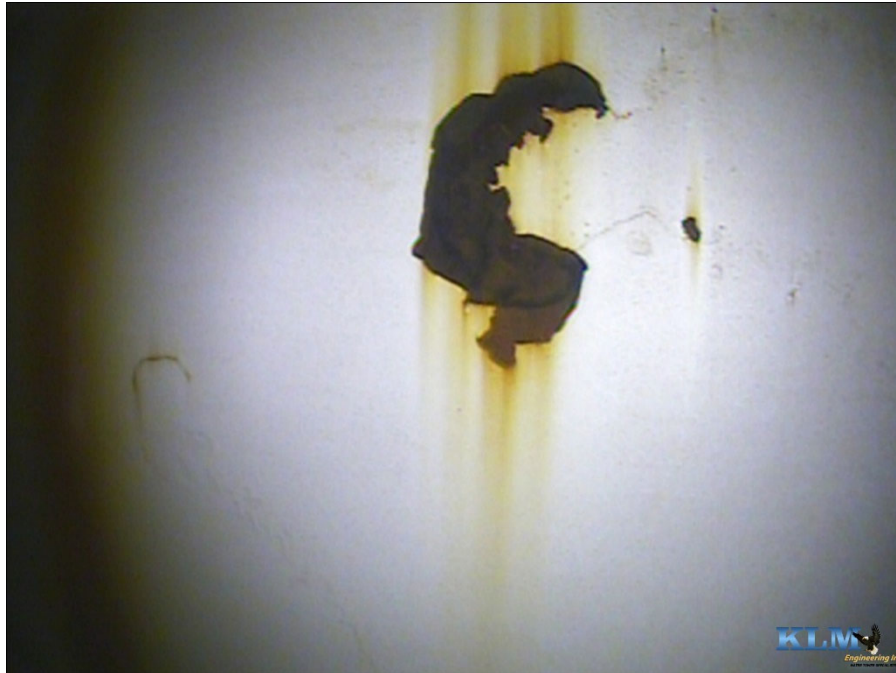
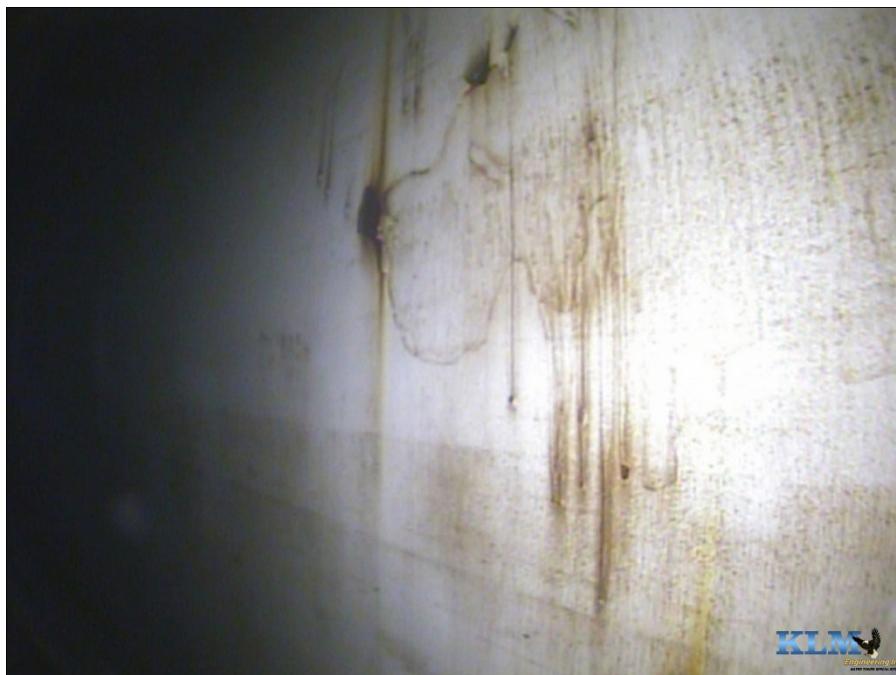
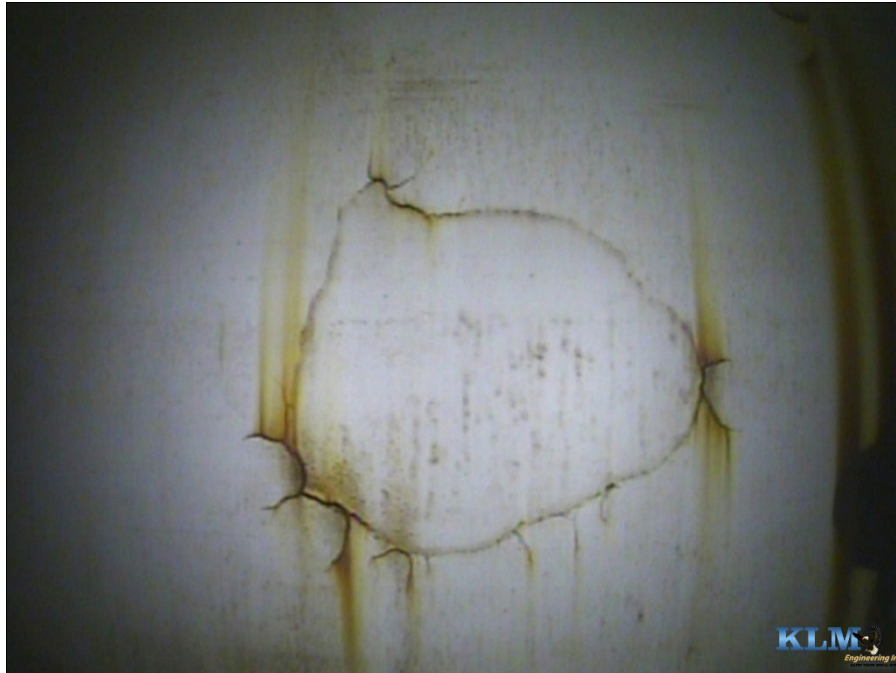
The tower was constructed, and the interior wet area originally coated, in 1993 by Caldwell Tank. According to Owner provided information, Maguire Iron fully reconditioned the interior wet area in 2007. The interior wet coating is in poor overall condition, with approximately five percent coating failures above the High-Water Line (HWL) and approximately 10 percent coating failures below the HWL. Failures above the HWL consist of corrosion along unwelded roof plate weld joints and rust nodules at random locations. Failures below the HWL consist of more widespread corrosion nodules on weld joints and random locations. Due to age and condition, the coating is not a candidate for repairs and should be replaced in its entirety within three years to maximize the life expectancy of the structure. See photos in Appendix A.

Photo No. 20
Coating failures and corrosion on shell, Note; indication of poor surface
preparation during repairs

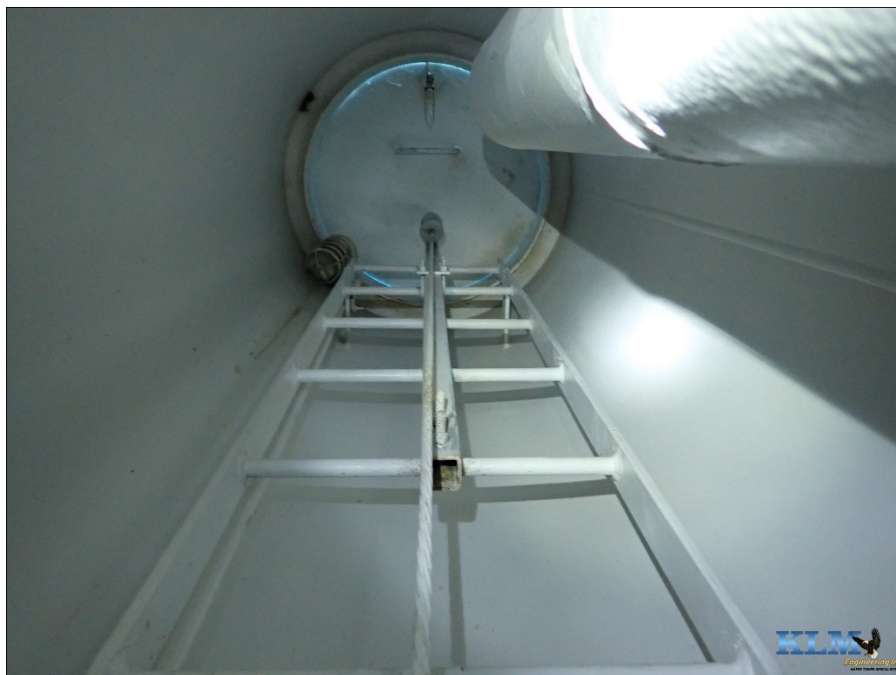
Photo No. 24
Top of drywell tube (looking up)

4.3.2 Replace the cable style safety climb devices on the ladders. The existing cables have been painted and are not deemed OSHA compliant. See photos 24, 30, and 31.

4.3.6 Replace the light fixtures with LED fixtures. See photos 24, 28, and 29.

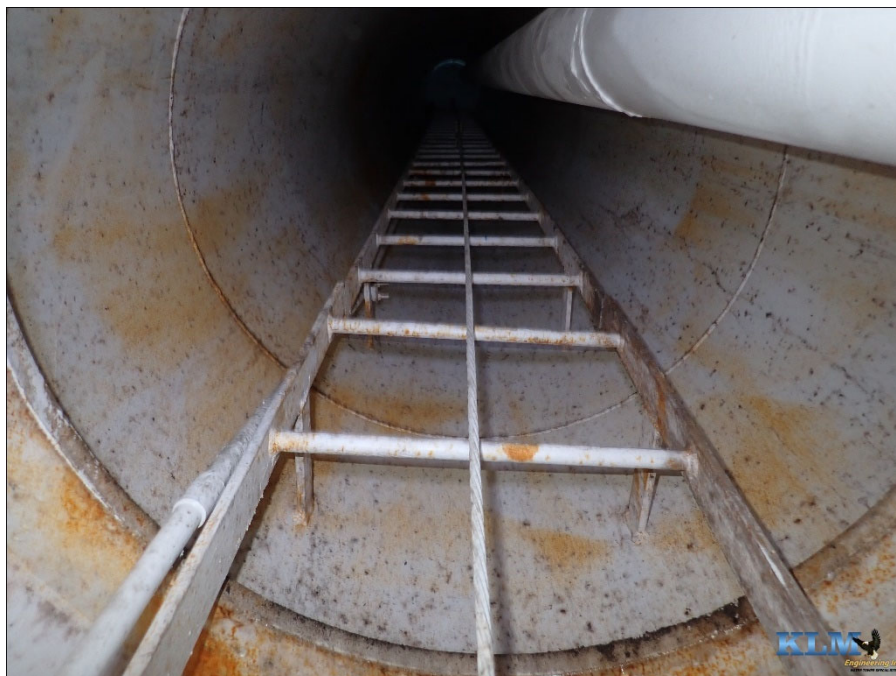
Photo No. 25
Lower section of the drywell tube

4.3.4 Install approximately six (6) half-moon cable brackets inside the drywell tube, equally spaced, for the attachment of electrical and coaxial cables. See photo 25.

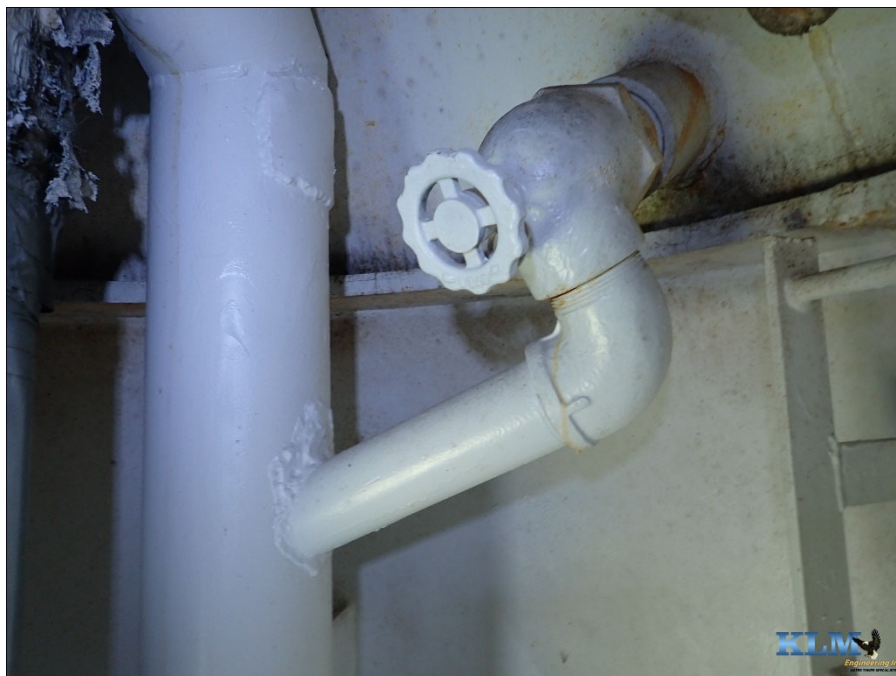
Photo No. 27
Bowl drain cleanout

4.3.3 Replace the existing bowl drain valve with a stainless-steel valve similar to those designed by Babco Company. Include a clear, rigid, high pressure hose connected to the overflow pipe. Include the replacement of the coupling in the bowl with a ½ coupling. This facilitates cleaning and draining the bowl below the inlet pipe level. See photo 27.

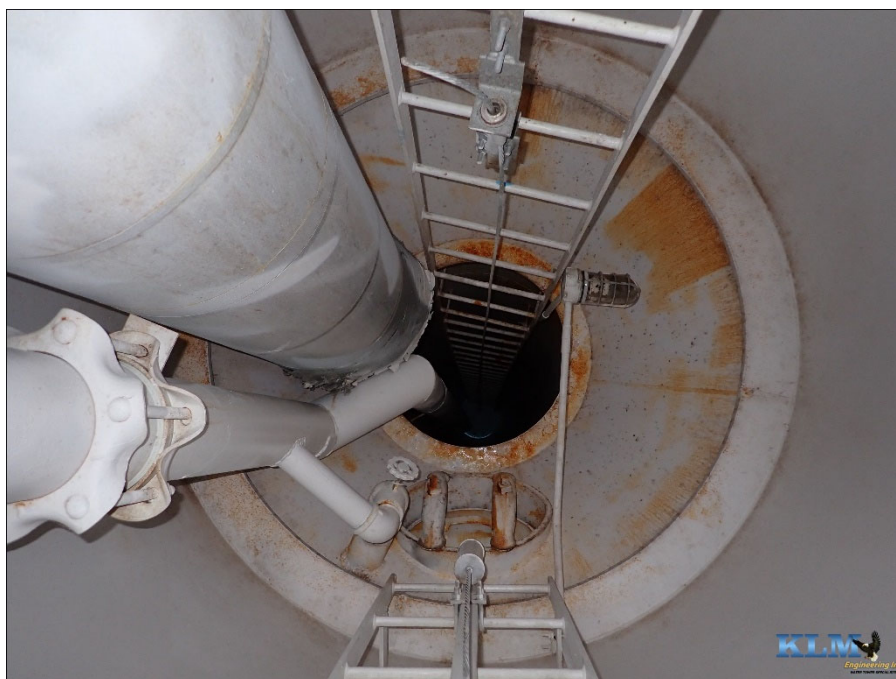
Photo No. 28
Overall condition of bowl

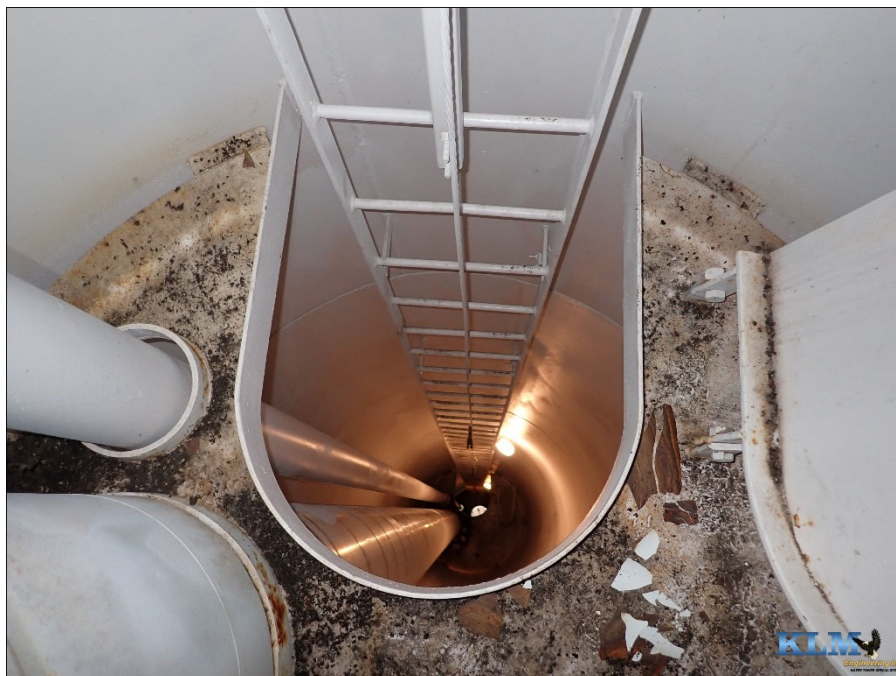
Photo No. 29
Top landing

4.3.1 Convert the top landing of the riser into a condensate ceiling by adding a ¼-inch by 2.5-inch flat bar and seal welding the perimeter to the pedestal. Install a drain in the low point of the landing with a connecting line to the overflow pipe. This will prevent condensation from running down the pedestal,

exacerbating defects in the coating, and leading to corrosion and additional painting and maintenance costs. See photos 29 and 30.

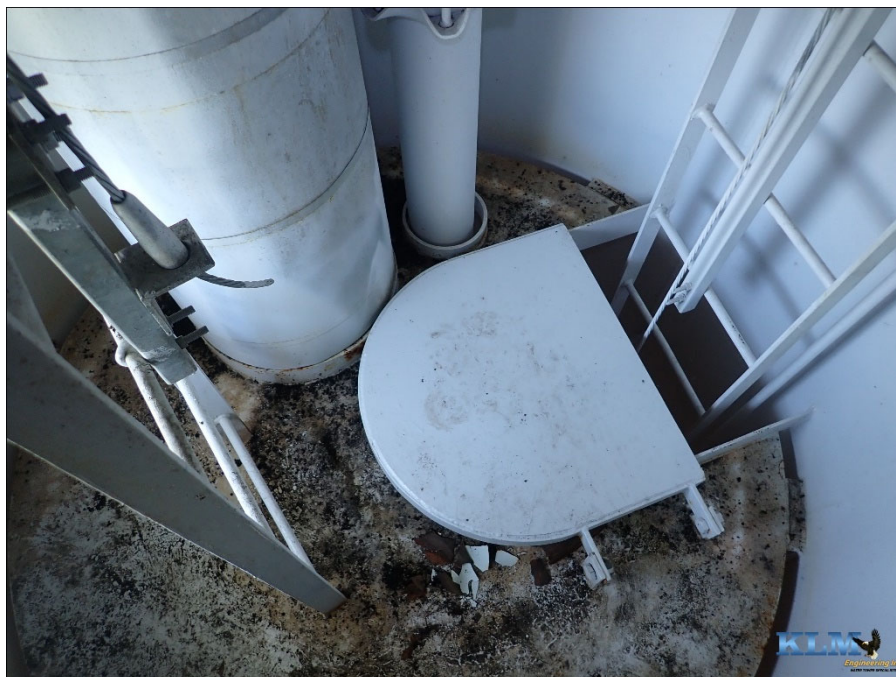
Photo No. 30
Top landing

4.3.7 Install ports in the center of the upper two platform floors to facilitate containment during the next reconditioning. See photos 30 and 31.

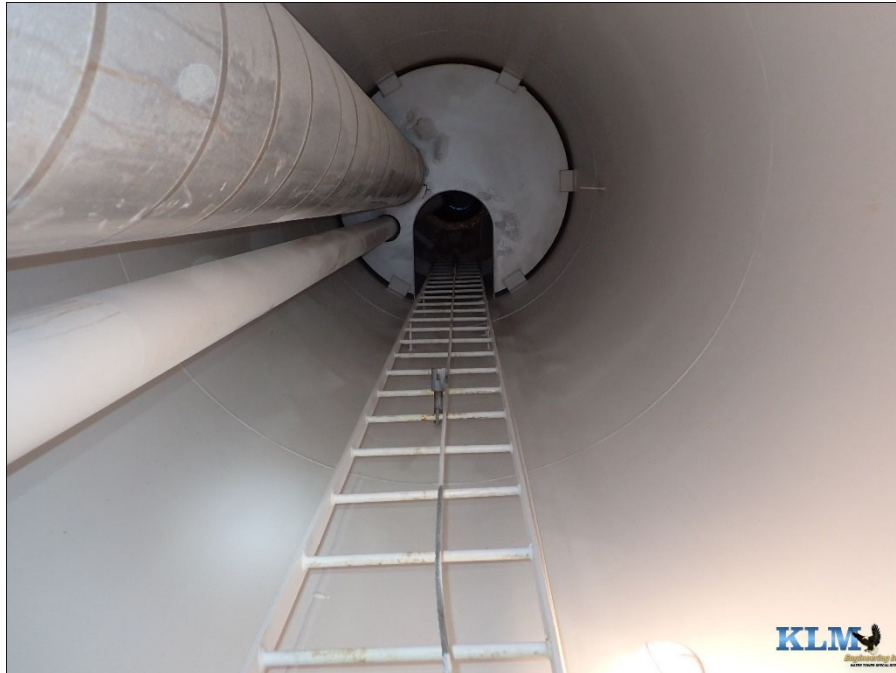
Photo No. 31
Overall conditions in riser (looking up)

4.3.5 Install approximately ten (10) pedestal stand-off brackets in the pedestal at 8-foot maximum spacing for the mounting of the electrical and coaxial cables. Move the electrical conduits along the ladders to the stand-off bracket to bring the ladders into OSHA compliance. See photos 31, 32 and 34.

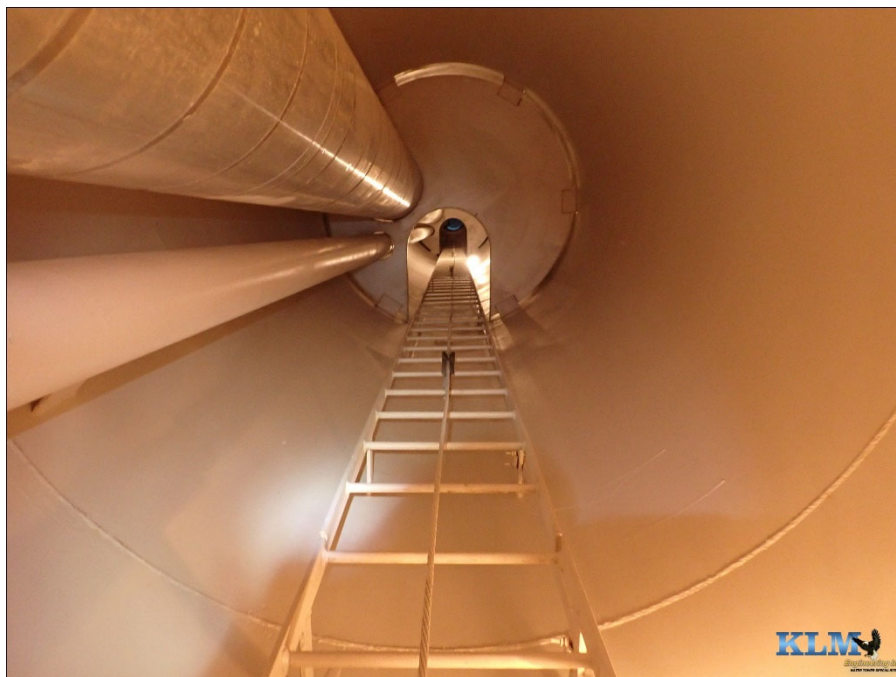
Photo No. 32
Conditions in riser (looking up)

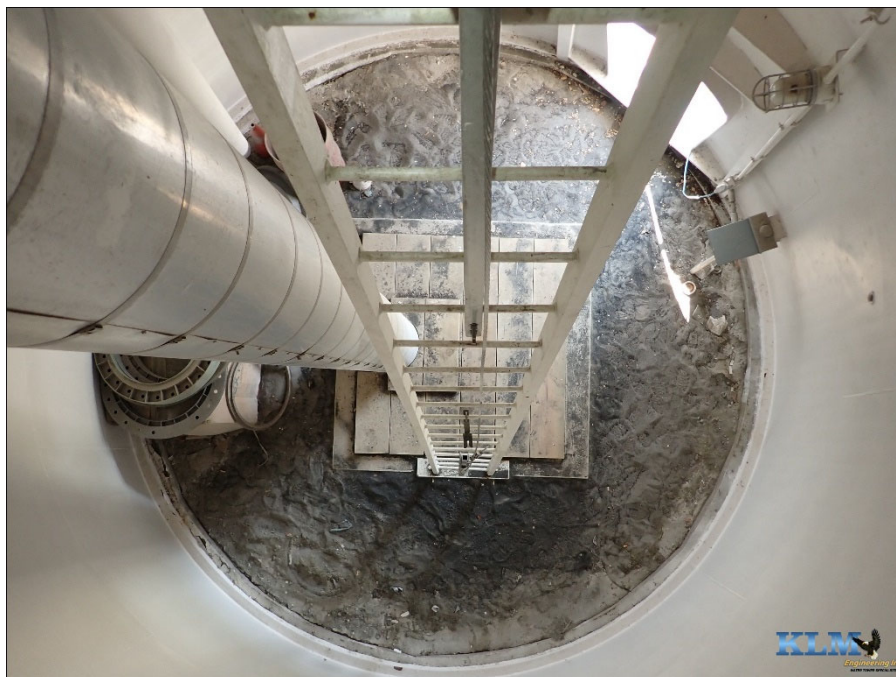
Photo No. 34
Base cone conditions (looking down)

4.3.8 Install a 4-inch-thick concrete pad in the base of the tower at grade, flush with the top of the existing ring wall foundation. Some of the existing soil will require removal. The concrete slab shall be reinforced with 6 x 6 – W1.4/W1.4 welded wire fabric, graded, float finished flat and level. See photos 34 and 35.

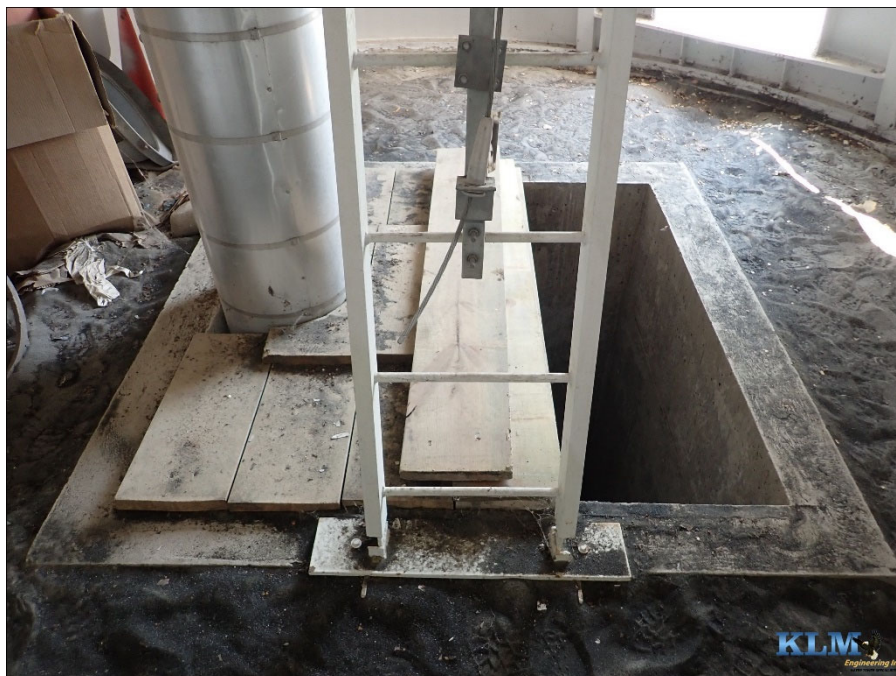
Photo No. 35
Valve pit

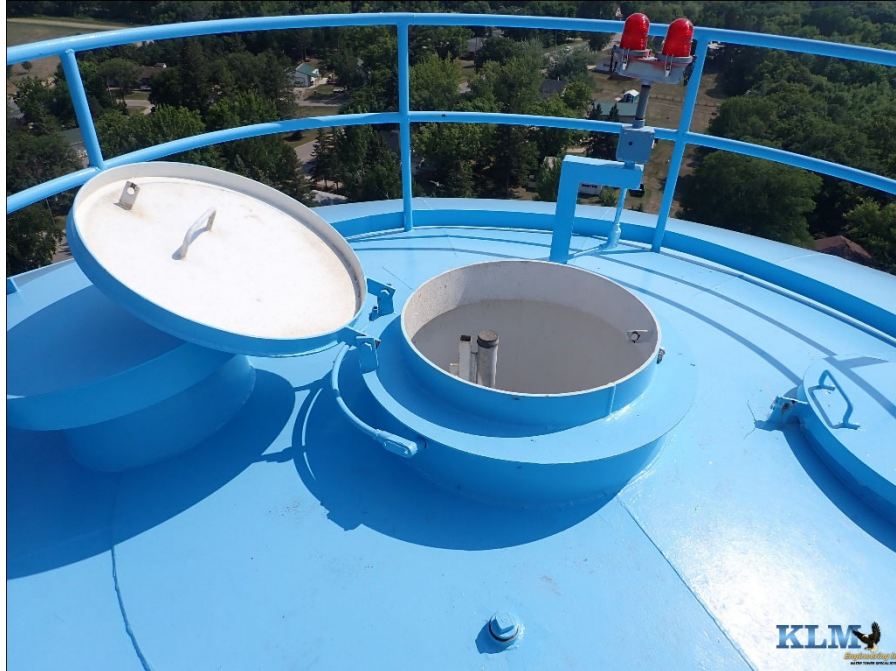
Photo No. 37
Overall conditions on roof

4.4.1 Install an anchor point on the exterior (roof side) of the drywell tube for securing safety harnesses with lanyards during egress from the drywell and transitioning from the drywell tube safety climb device to the tower roof. See photo 37.

4.4.2 Replace the drywell tube manway cover with an aluminum cover and stop chain. This make lifting the larger cover easier and limit the angle of travel of the cover, (prevent the cover from opening 180 degrees). See photo 37.

4.4.5 Replace the double aviation light with a new double LED style aviation light similar to Hughey & Phillips L-810. See photo 37.

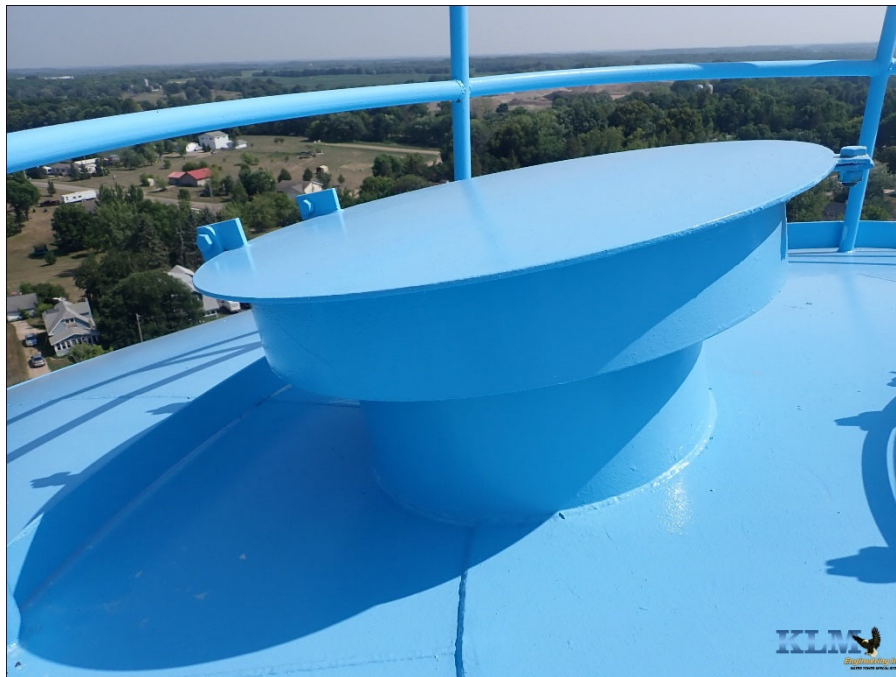
Photo No. 38
Finial vent

4.4.3 Replace the tank finial vent with a 24-inch diameter aluminum pressure pallet style vent. The new vent and vent screen design should meet AWWA D100-11 and Department of Health regulations. The removable top will improve ventilation, provide access to the tank interior during reconditioning, and aid in compliance with OSHA Confined Space Entry Requirements. See photo 38.

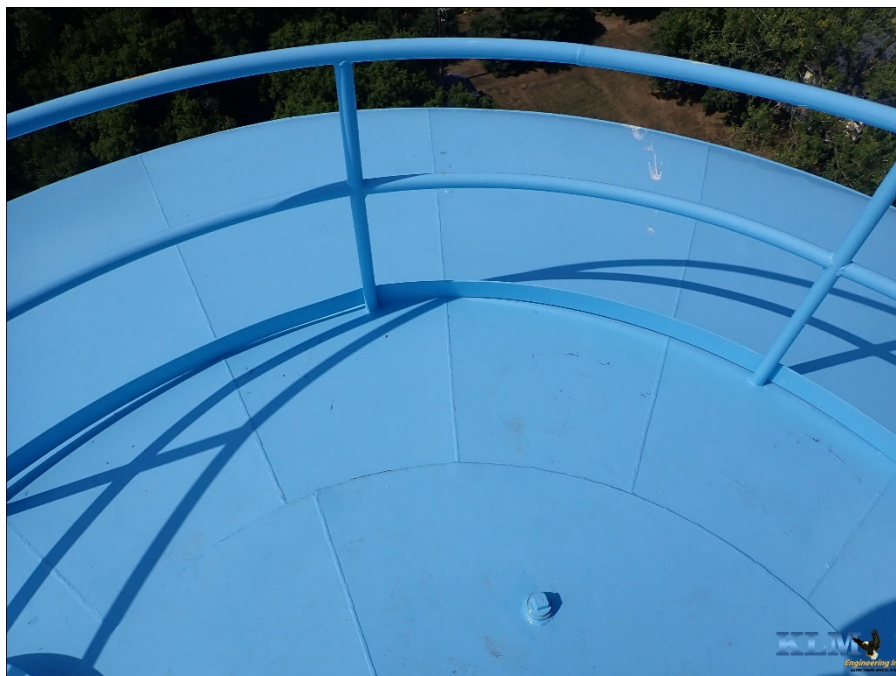
Photo No. 41
Roof coating conditions

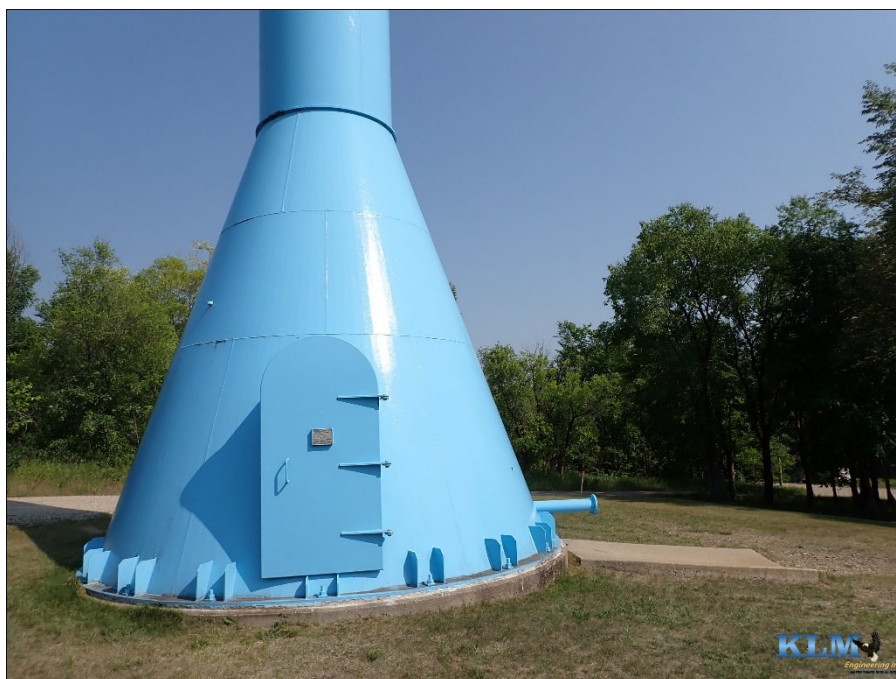
Photo No. 46
Overall condition of base cone

4.4.8 Urethane caulk around the perimeter of the base cone where it meets the concrete foundation. This will prevent water intrusion and corrosion along that seam. See photos 46 and 49.

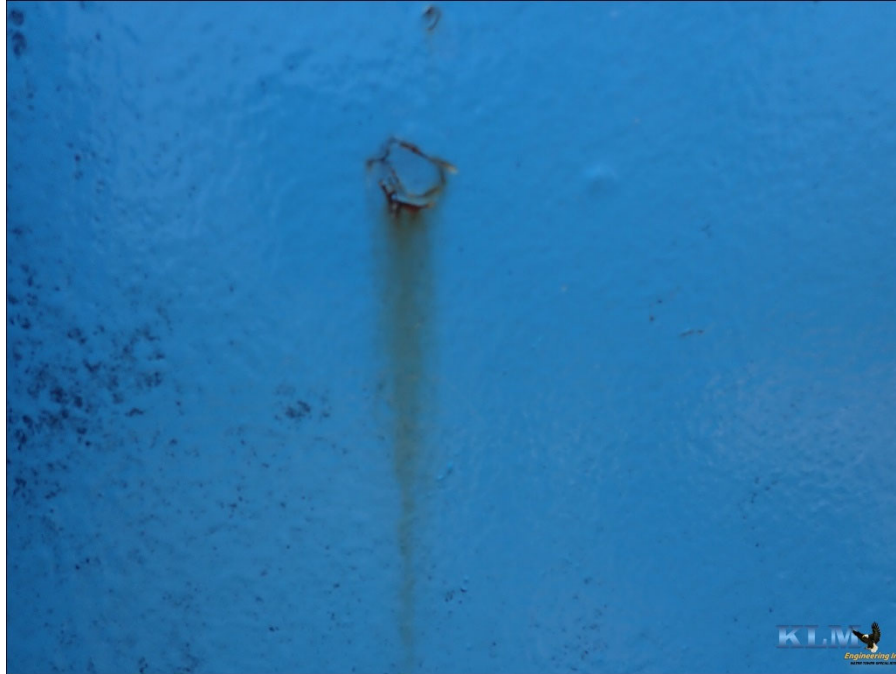
Photo No. 47
Isolated corrosion on base cone

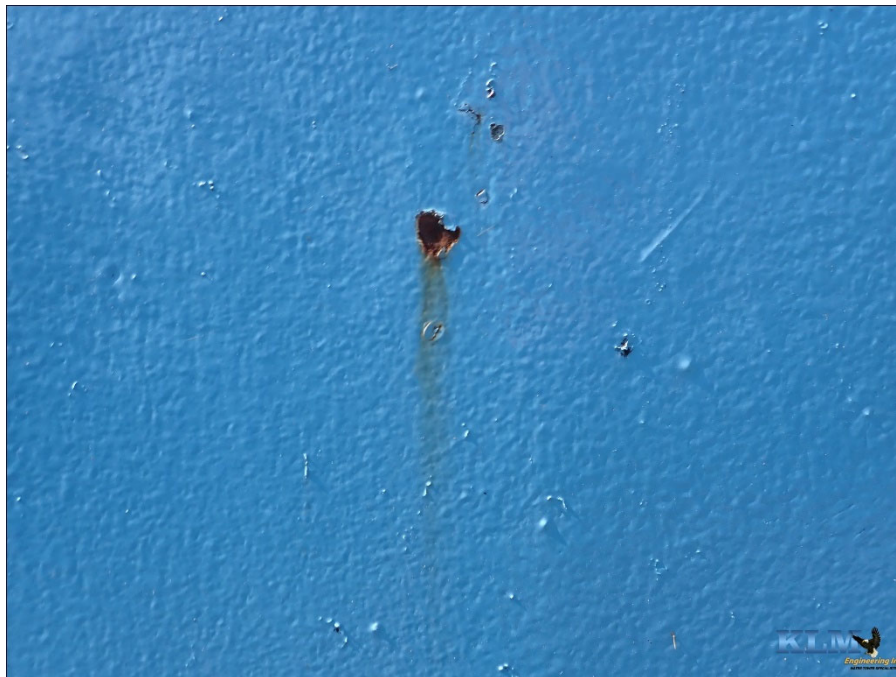
Photo No. 48
Isolated corrosion on base cone

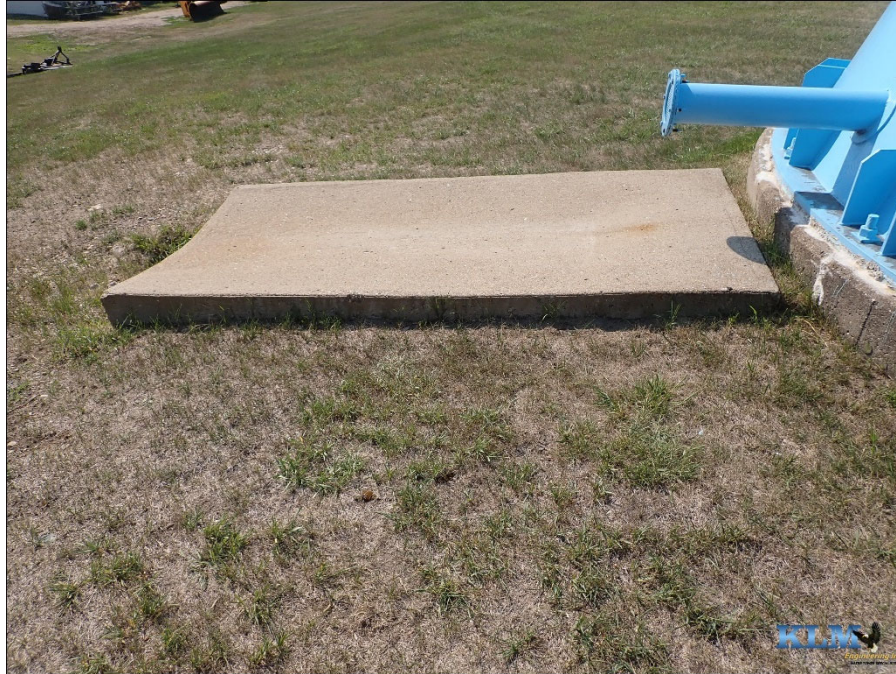
Photo No. 49
Overflow and splash pad

4.4.7 Per Minnesota Department of Health, modify the overflow discharge pipe outlet by installing a downward bend on the end and replace the existing overflow pipe screen with a corrosion-resistant, heavy-gauge #24 mesh screen. See photo 49.
